Bayou State Inspections

Page 2 of 83
sample office building report

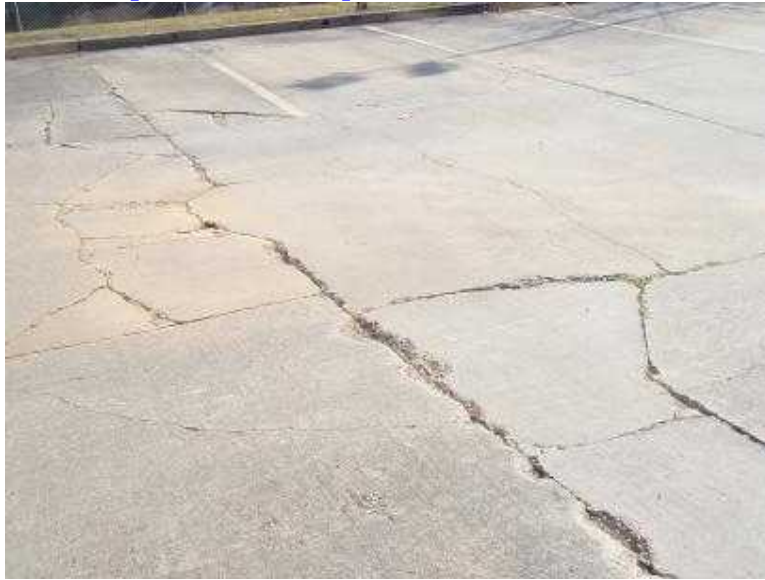
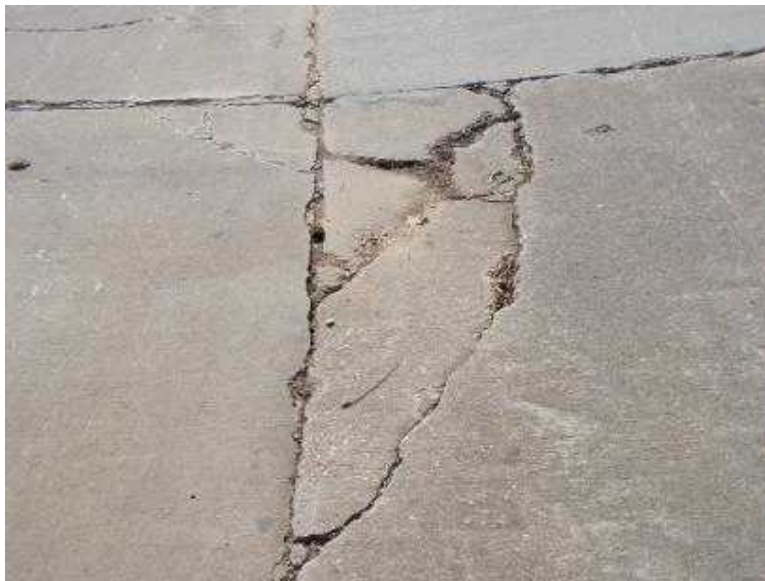
Driveway: Concrete Cracking and breaking are noted at the parking lot driveway areas; they are uneven. Some areas are lower than others.

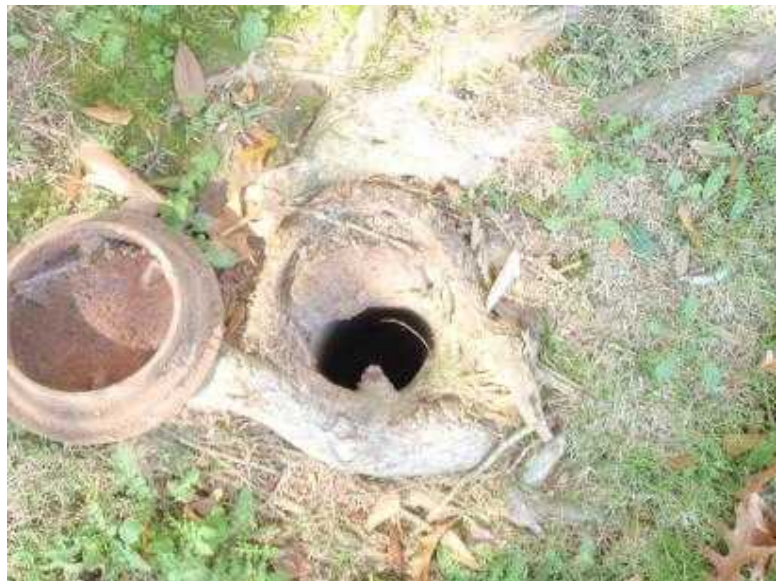
7. Vegetation: Shrubs/Weeds/
Trees The right side of
the building has a
plumbing drain pipe that
the tree roots have grown
around. BSI recommends
monitoring this to
prevent damage to the
pipe.

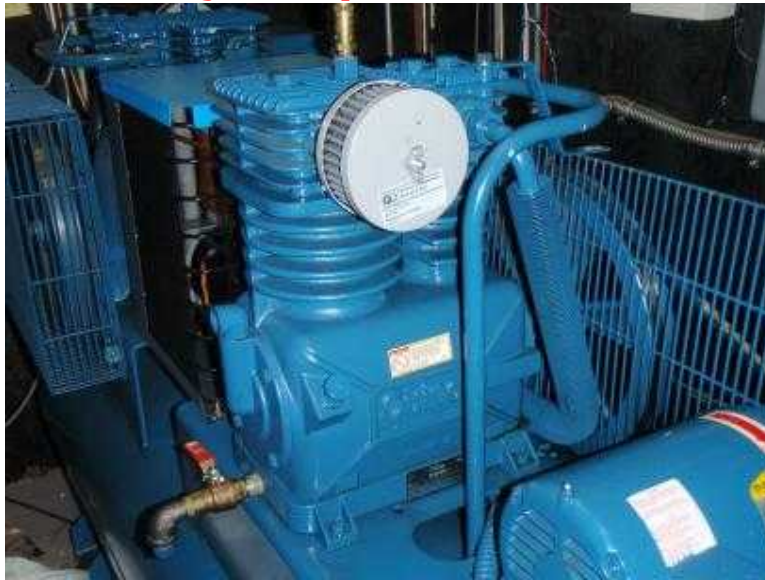
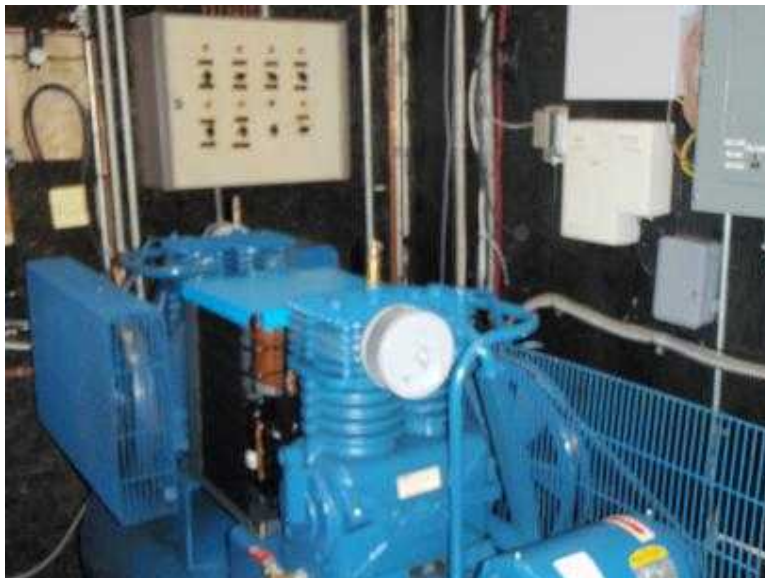
16. Building Air Compressor Quincy **The building air compressor is in good overall condition and functioning properly at this time. However a small oil leak is noted at the compressor pumps that should be repaired as a general maintenance item. This should also be put on the buildings weekly checklist.**

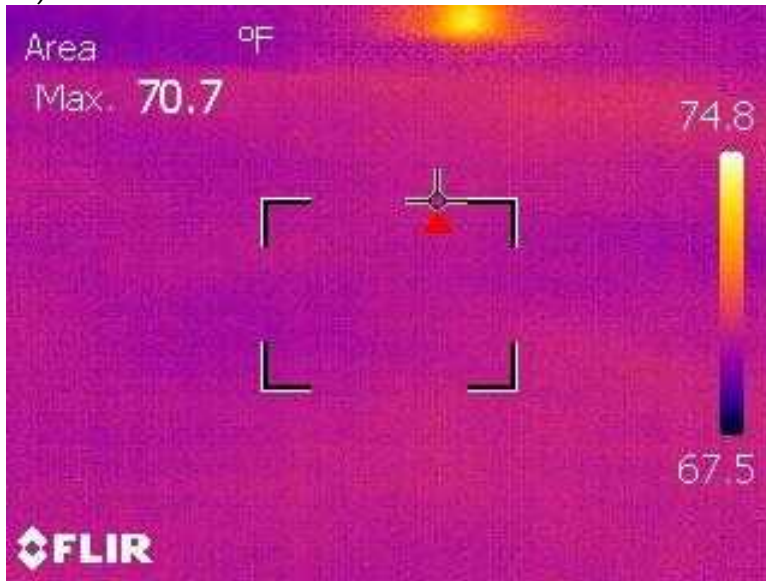
3. Material: Rolled asphalt This roofing system has been replaced recently (within the past six years) and is well sloped to the roof drains. The roof was photographed on 12-27-2012 and showed no standing water at the time. Small pockets of pooling water were noted after the heavy rain on 12-28-2012; this is common and largely unavoidable, and the roof appears to be in very good condition as Infrared Imaging shows no signs of active roof leaks. BSI returned to the roof on the final day of the inspection (12-29-2012) to find only a few areas with standing water. The roof is in good overall condition.

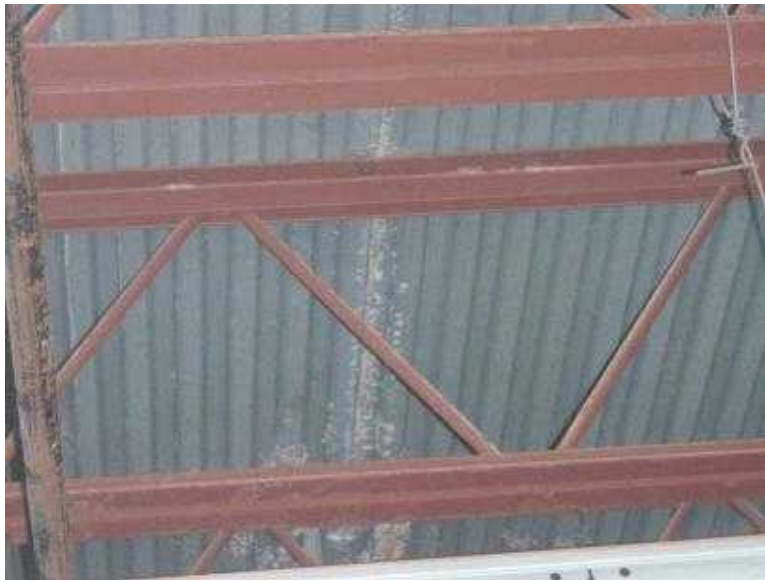
4. Roof under decking Metal Many areas of the under side of the roof have rust indicating that the old roofing leaked in many different areas. All of these areas were tested and found to be inactive at this time.

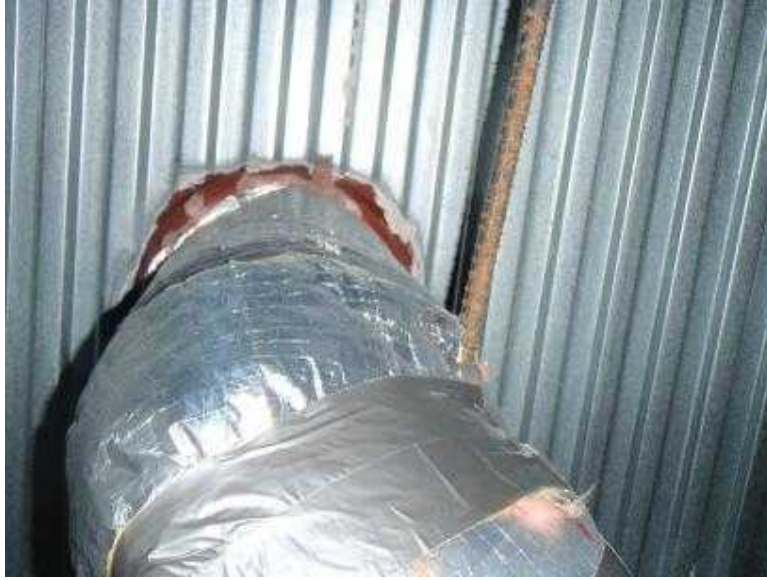
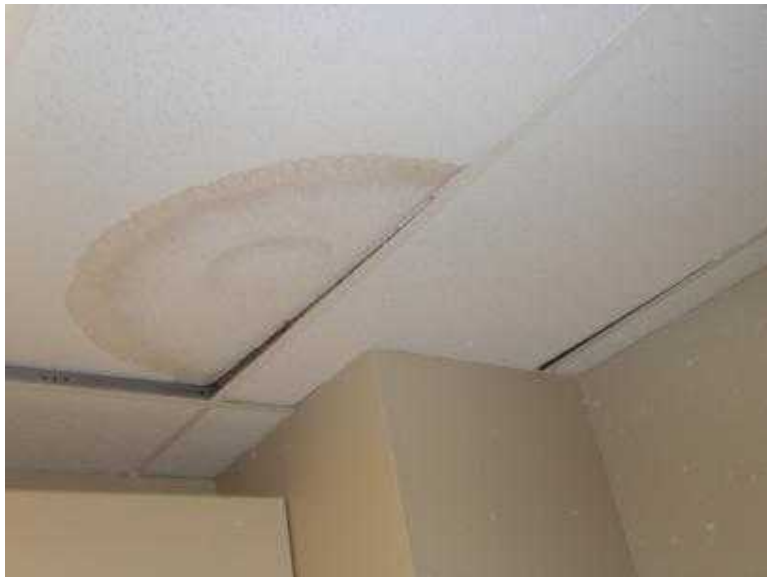
11. Roof Drains Metal Previous leaking is noted at several of the roof drains. All are inactive at this time; likely due to the newer roof installation.

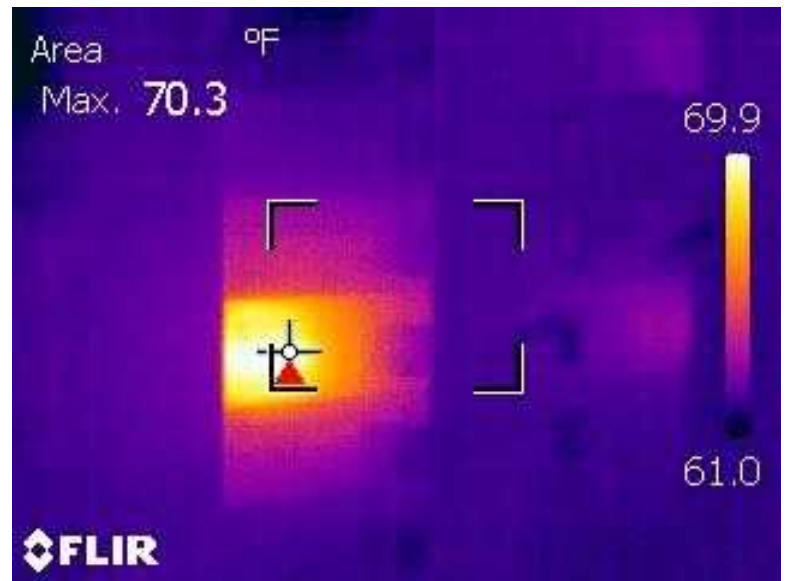
26. Breakers: Copper Bolt On
Circuit #26 was hot;
overheated breakers
noted, evaluation by a
licensed electrician is
recommended.

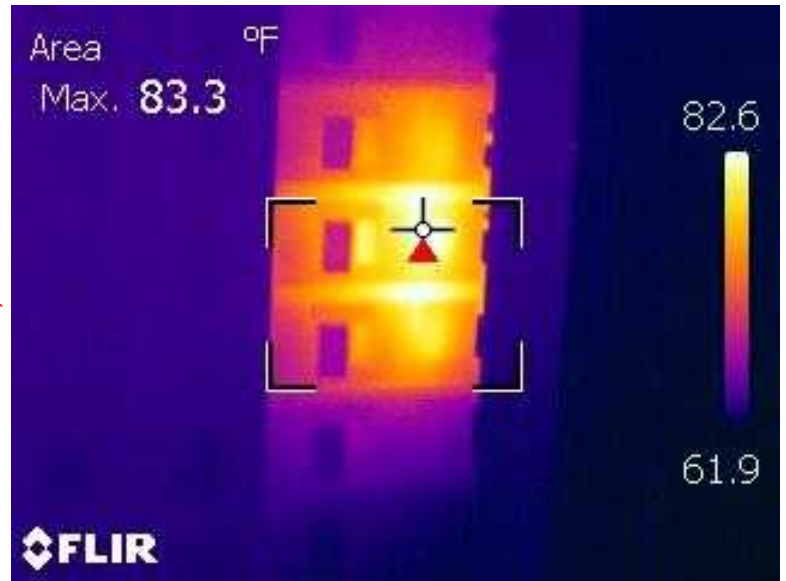
32. Breakers: Copper Bolt On Circuit #2, 4, 22, 24, and 26 was hot; overheated breakers noted, evaluation by a licensed electrician is recommended to determine the cause of these over-loaded breakers or if the breaker dissimilar metal OL strips have become weak.

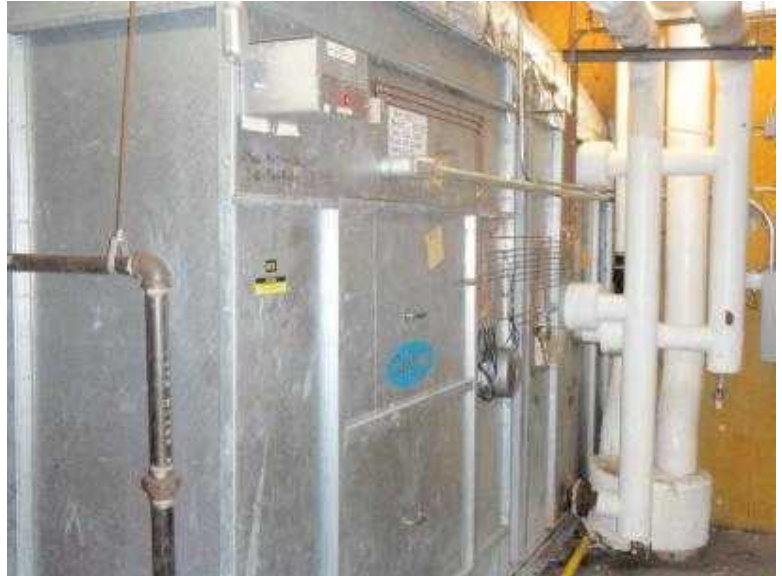
This is a photo of the AHU's located on each floor. All of the units are original to the building. Maintenance and repairs must be expected due to the age of the units.

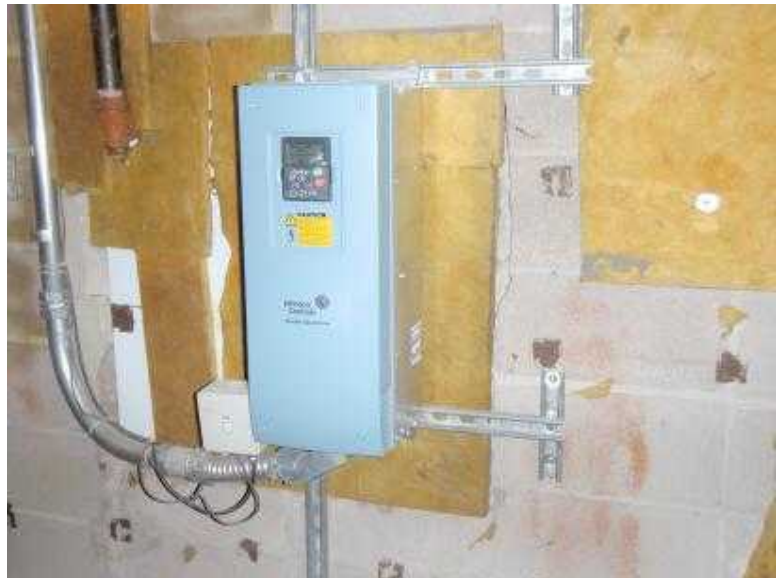
Johnson Controls This photo of the AHU's Variable Frequency Drive located in the mechanical rooms with the units. All of the drives have been replaced since the original units were installed 30 years ago and will likely not require replacement in the near future.

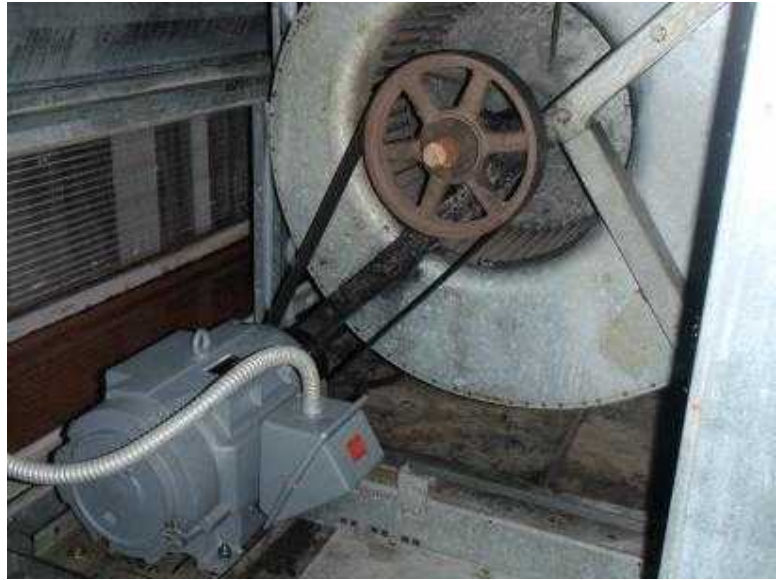
11. Motor: Westinghouse This photo of a typical AHU motor that is toggled by the VFD which in turn drives the blower's squirrel cage.

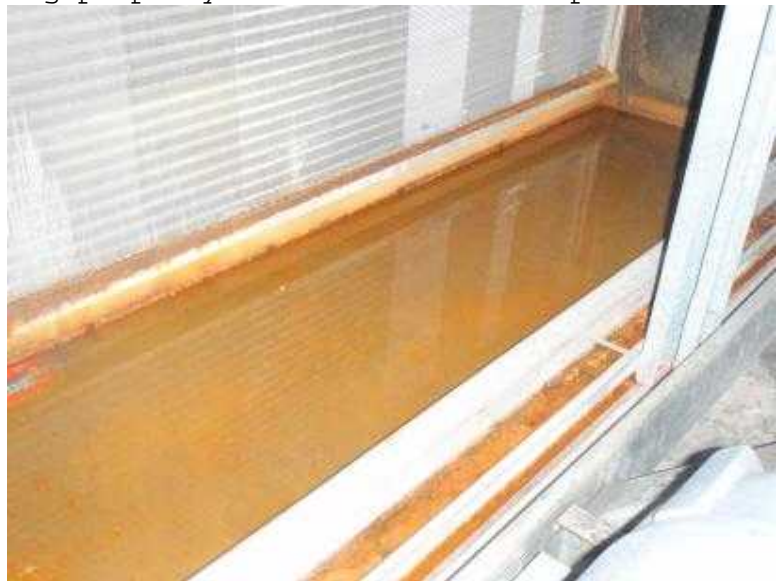
14. Condensate Removal: Metal to floor drain **The coils were cleaned recently. The primary drain pan, however, was clogged and full of water, sediment, and debris. This is likely due to cleaning out the coils without also cleaning the pan so that the debris from the dirty coils stayed in the pan and clogged it up. BSI recommends unclogging and cleaning the pan and ensuring that, in the future, the pan be cleaned as well as the coils. Due to the rust in the pan it may need to be re-coated to prevent leaking at rusted areas; at this time BSI did not note any visual leaking of the secondary drain pan.**

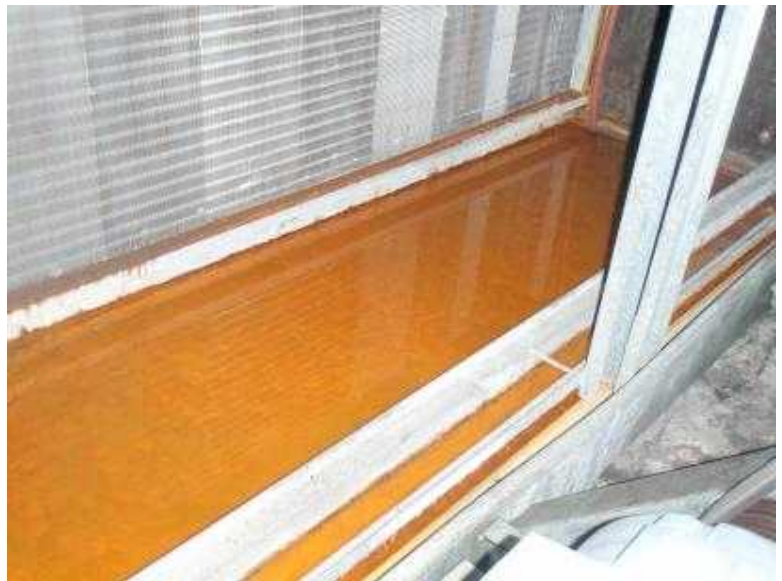
38. Condensate Removal: Metal to floor drain **The coils were cleaned recently. The primary drain pan, however, was clogged and full of water, sediment, and debris. This is likely due to cleaning out the coils without also cleaning the pan so that the debris from the dirty coils stayed in the pan and clogged it up. BSI recommends unclogging and cleaning the pan and ensuring that, in the future, the pan be cleaned as well as the coils. Due to the rust in the pan it may need to be re-coated to prevent leaking at rusted areas; at this time BSI did not note any visual leaking of the secondary drain pan.**

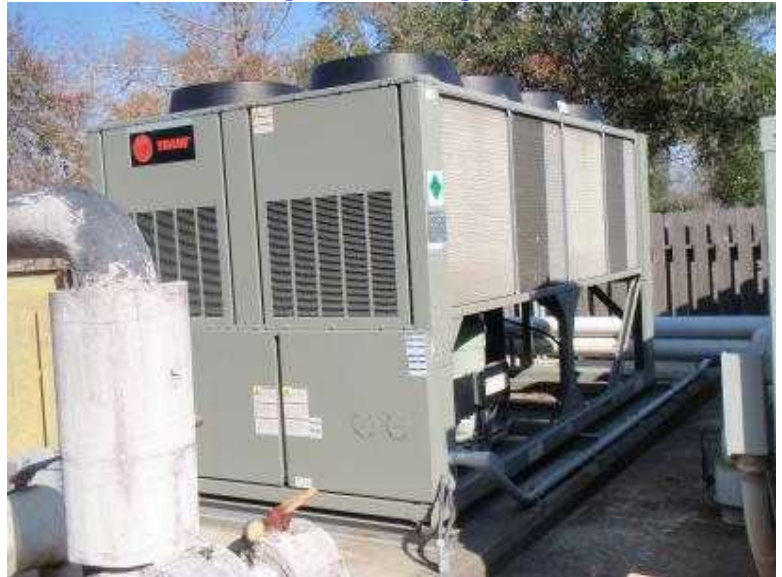
61. A/C System Operation: Functioning properly at time of this inspection
This unit takes almost all of the building's cooling load.
62. Exterior Unit: Pad mounted

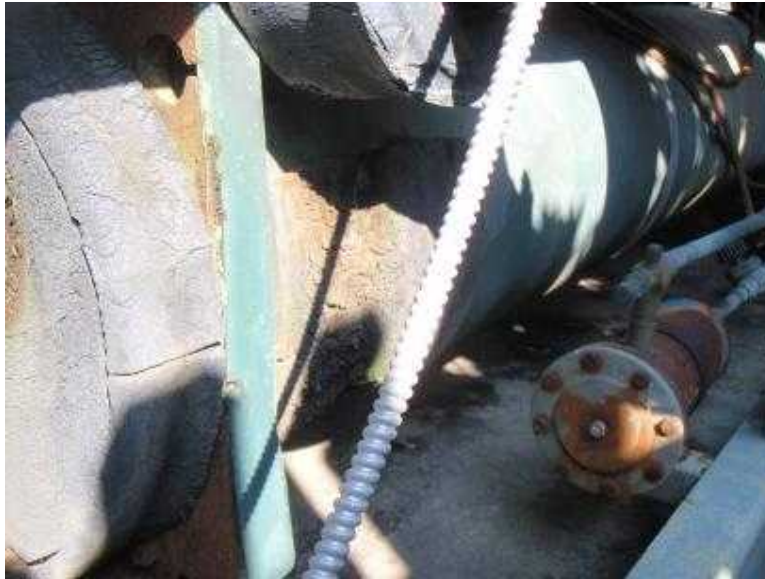
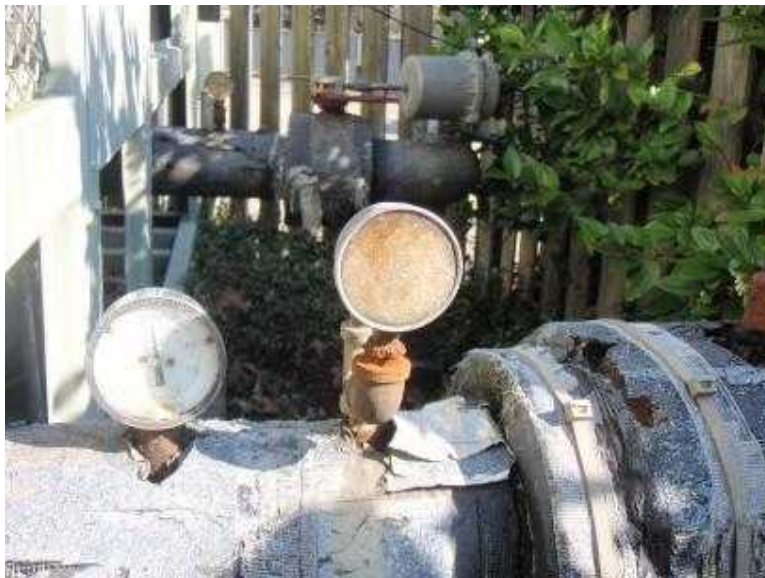
71. A/C System Operation: Not in operation at time of this inspection due to the buildings HVAC load. The gauges and coils of the second chiller are inoperable and or in very poor condition and are recommended to be replaced. The original (older) chiller is only used during high demands for cooling when the primary (new) chiller cannot keep up with the buildings cooling load. The older unit is in poor condition and has a high operating cost; BSI suggests that replacement should be expected in the very near future.

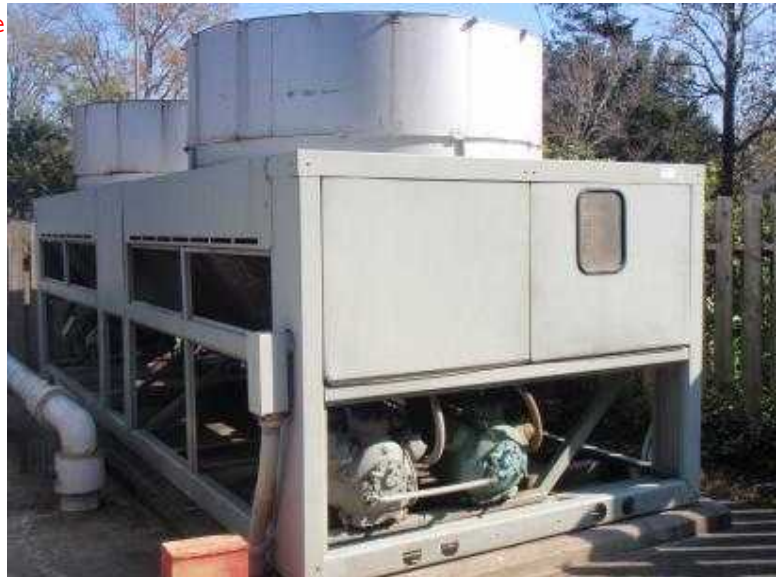
72. Exterior Unit: Pad mounted The gauges and coils of the second chiller are inoperable and or in very poor condition and are recommended to be replaced. The original (older) chiller is only used during high demands for cooling when the primary (new) chiller cannot keep up with the buildings cooling load. The older unit is in poor condition and has a high operating cost; BSI suggests that replacement should be expected in the very near future.

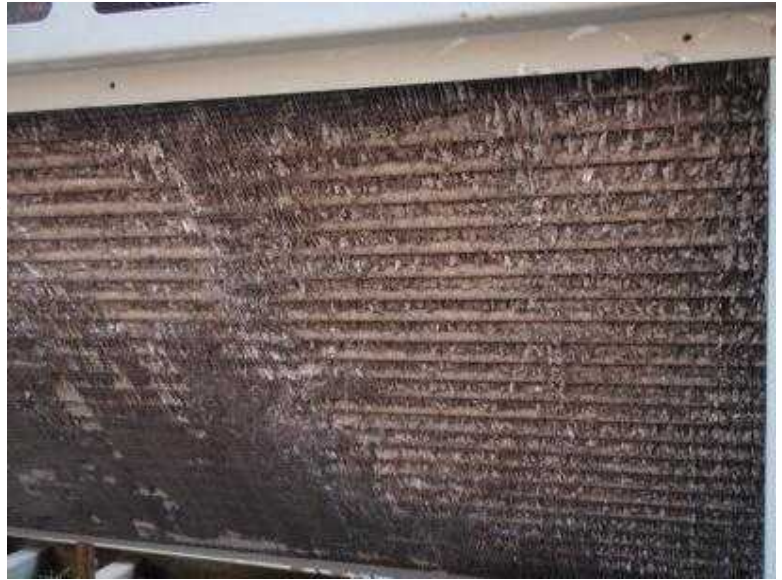
78. Visible Coil: Copper core with aluminum fins The coils of the older chiller unit are in very poor condition such that cleaning or trying to repairs them would likely result and further damage. A qualified air conditioning contractor is recommended to evaluate and estimate repairs.

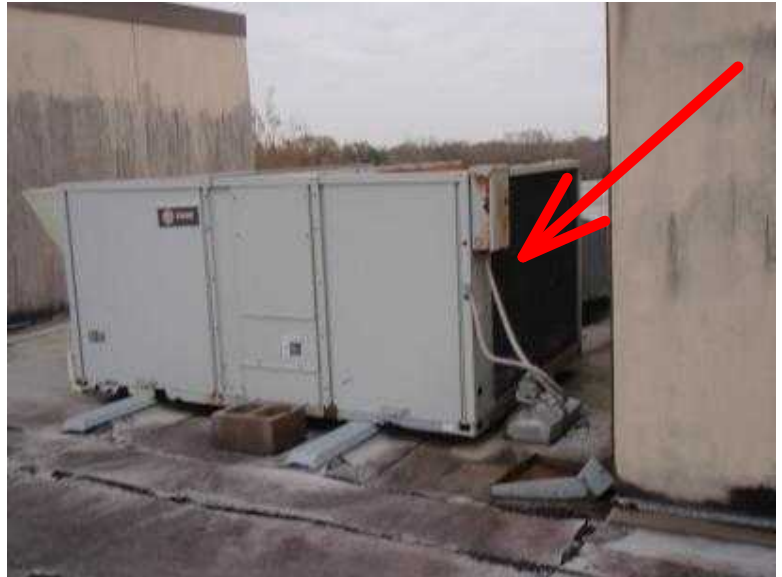
80. A/C System Operation: Inoperative, unit appears to have been terminated and no longer in use. BSI recommends replacement or removal of the unit; as it has not been in operation for the past two years according to the building maintenance department. Further evaluation by an HVAC contractor is recommended.

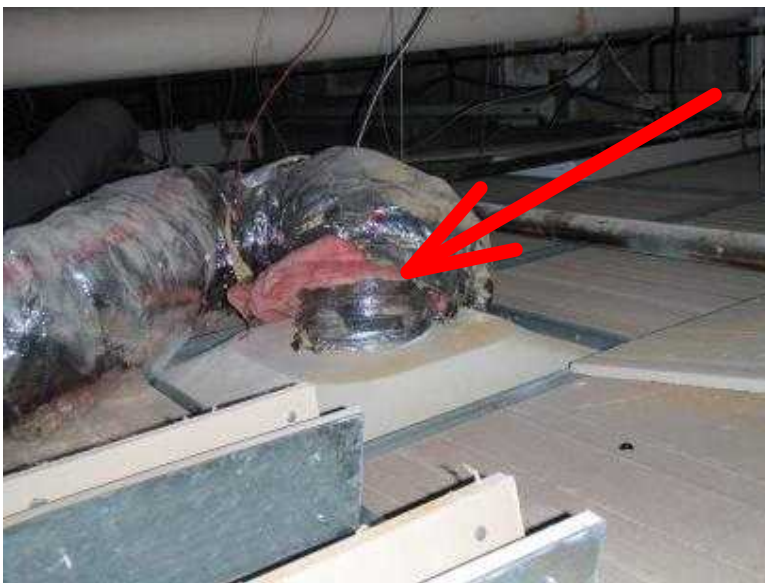
89. Exposed Ductwork: Rigid metal insulated ducts with flexible ducts
Replace the missing diffuser grills at the supply drops on the 5th floor back left side offices. Resecure and seal all ducts at the register connection in the plenums throughout the building.

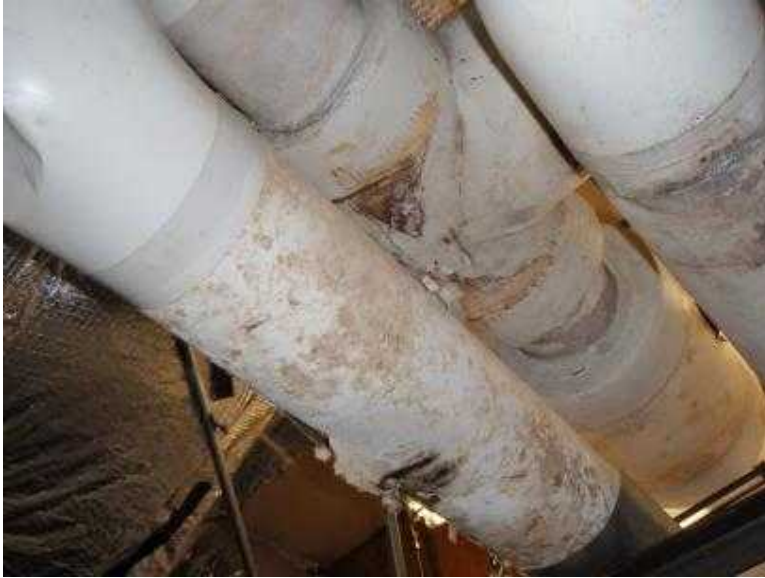
90. Chill Water Piping Insulated Rigid Piping **Correct the leaking at the chill water piping in varies locations in the mechanical rooms. A qualified contractor is recommended to further evaluate and repair.**

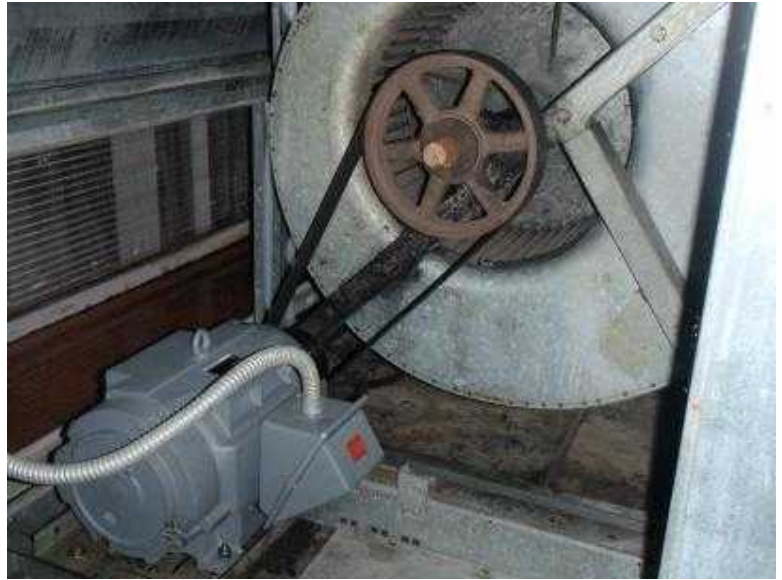
91. Blower Fan/Filters: Direct drive with disposable filter Photo of AHU motor and blower.

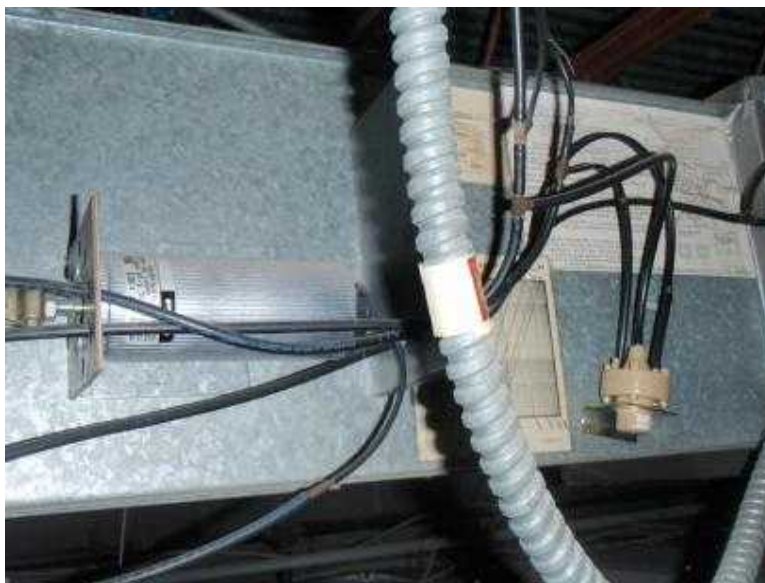
10. Controls: Limit switch Many of the VAV boxes have been opened and left that way for repairs and adjustments. The building maintenance mechanic was called throughout the day to manually adjust many of the VAV's in various office areas.

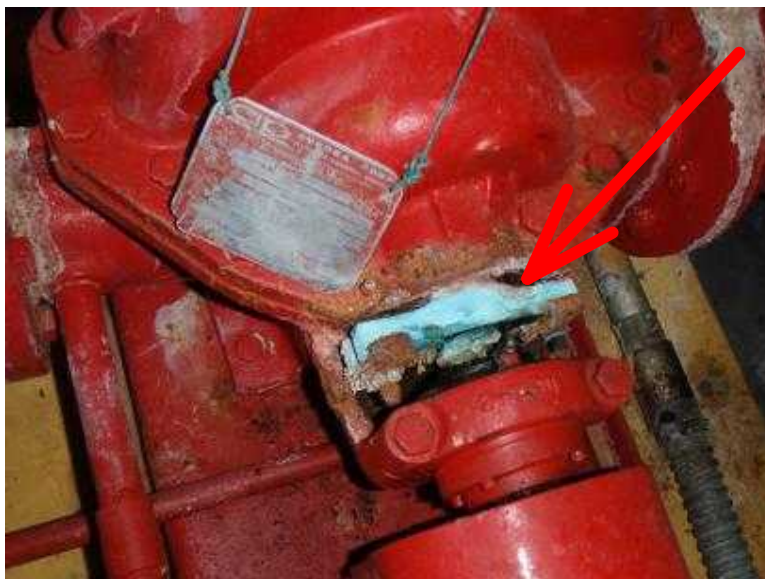
| 7. | <input type="checkbox"/> | <input type="checkbox"/> | <input type="checkbox"/> | <input type="checkbox"/> | <input checked="" type="checkbox"/> | Sprinkler / Fire Supression System Building Sprikler System Although BSI does not test this system several issues and problems were noted from the visual inspection. BSI recommends an inspection be performed by a sprinkler testing company as well as repairs of all defects. Leaking is noted at the first floor mechanical room at several connections. |

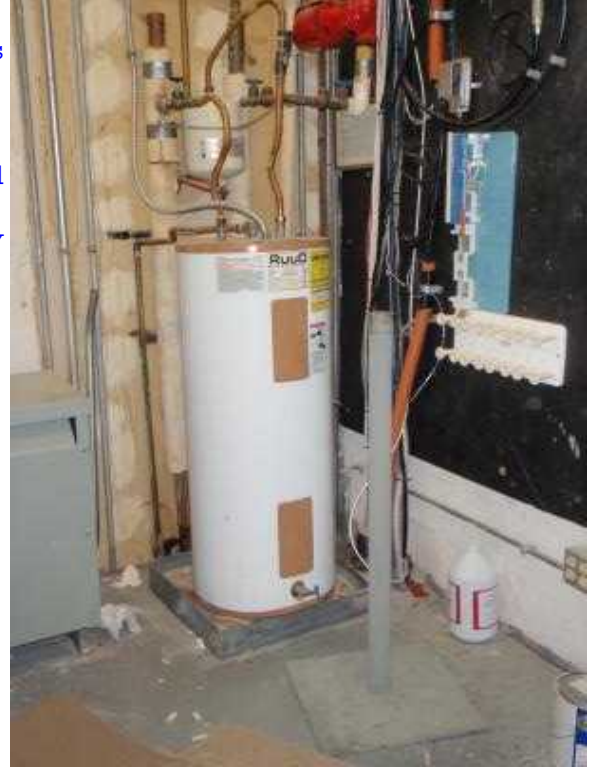
9. Water Heater Operation: Functional at time of inspection. The HVAC unit has exceeded its' manufacturer's designed life (12 Years). Although units can last years beyond their life expectancy, BSI would recommend to budget accordingly. BSI recommends obtaining a home warranty due to the age of the unit.

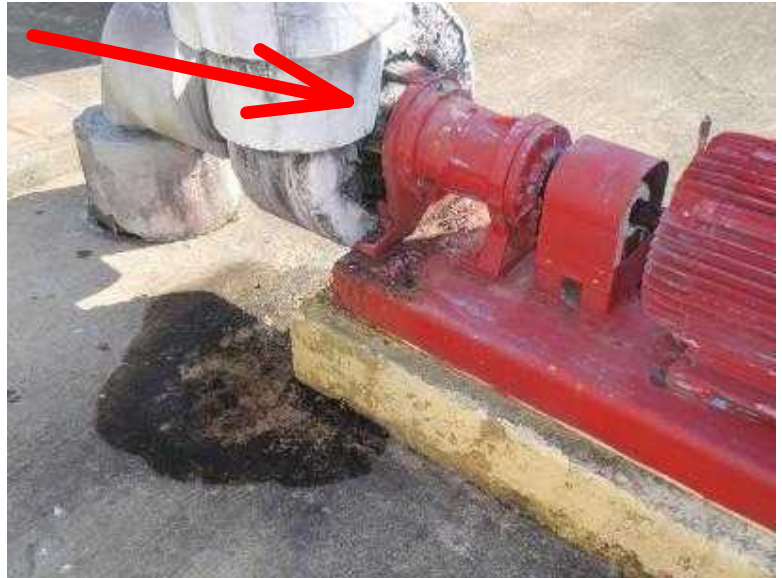
15. Chilled Water Pump Chill Water Pump #1 The chilled water pump & motor have exceeded the manufacturer's designed life (12 Years). Although units can last years beyond their life expectancy, BSI would recommend to budget accordingly. Repair the leak at pump #1; see photo.

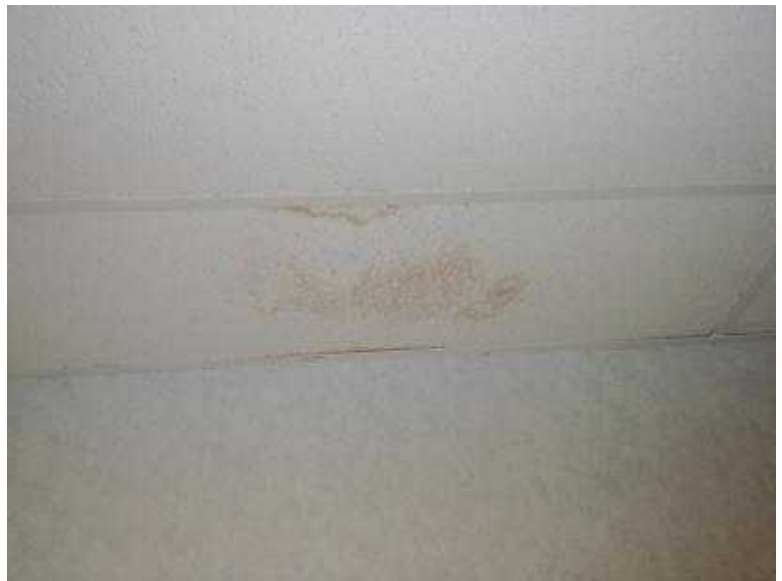
- 21. Closet:
- 22. Ceiling: Tile Water stains were noted in the back left corner.

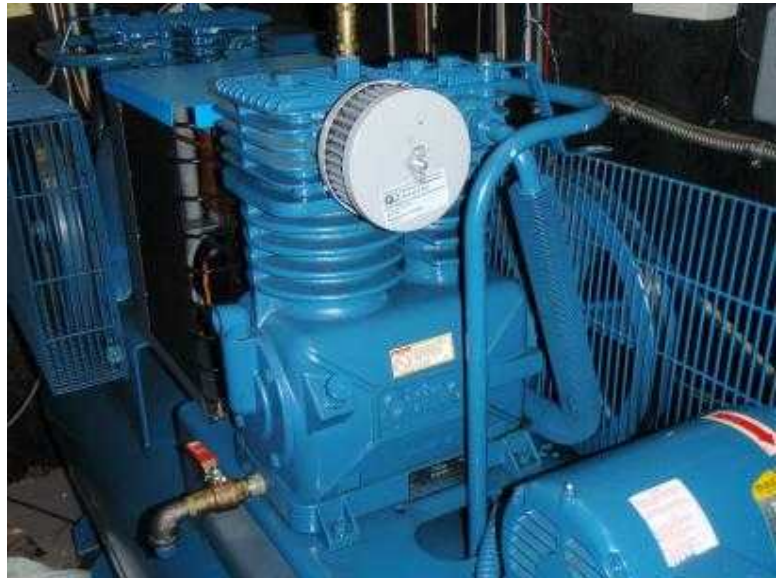
3. Floors: Concrete Repair/replace the oil leak at the bottom of the Quincy compressor in the electrical closet on the third floor.
