Bayou State Inspections  
Lafayette, LA 70508  
337-988-9020

# Real Estate Inspection Report

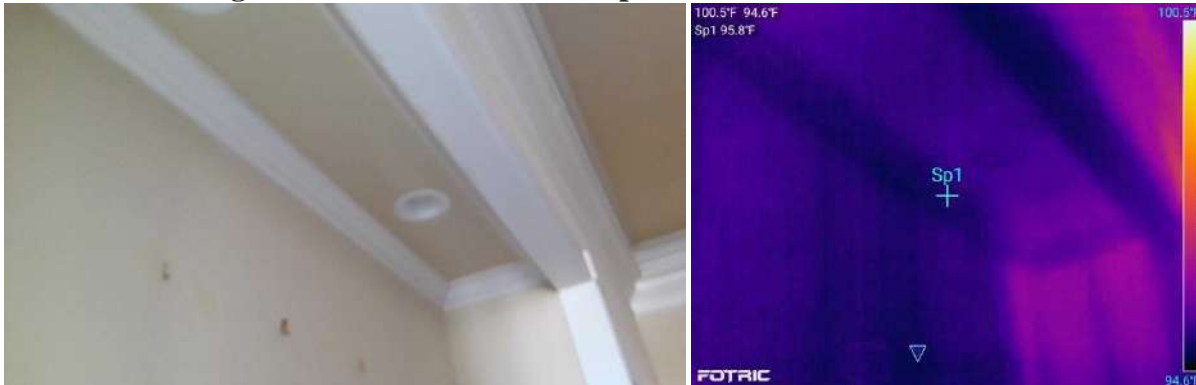
Photo #10: Dining Room Hutch at End of Inspection
