Bayou State Inspections

Page 2 of 83
sample office building report

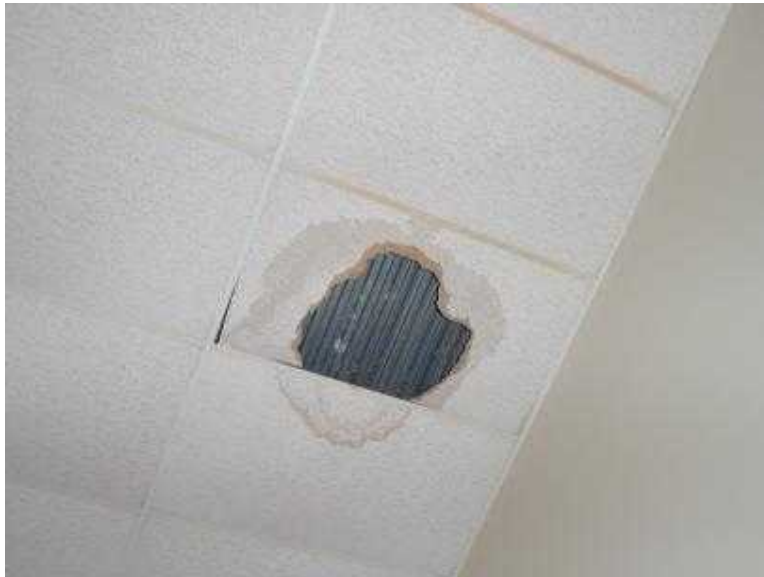
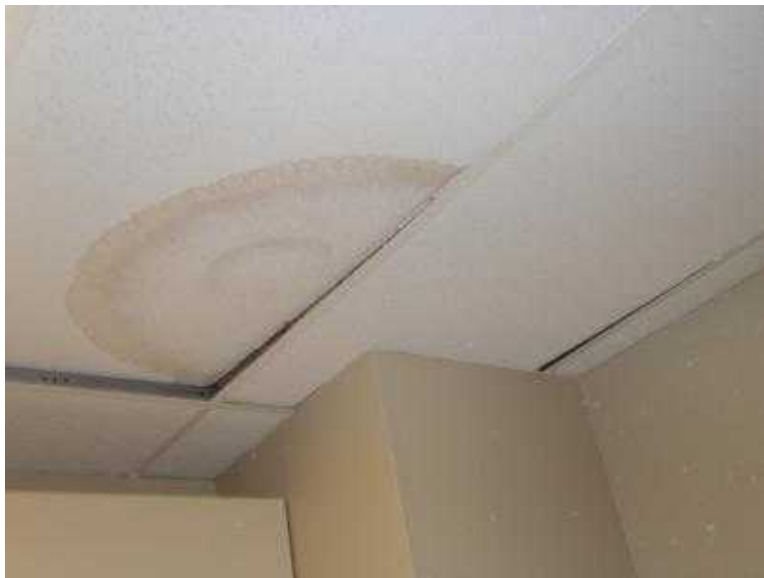
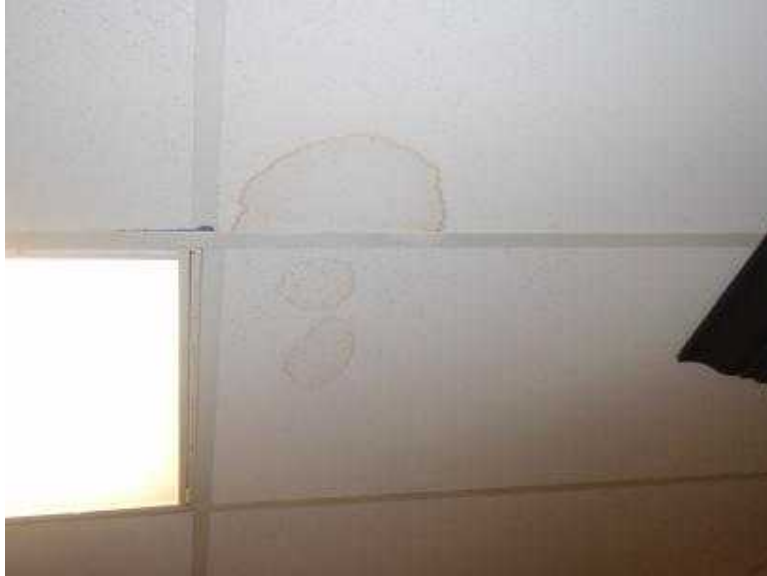
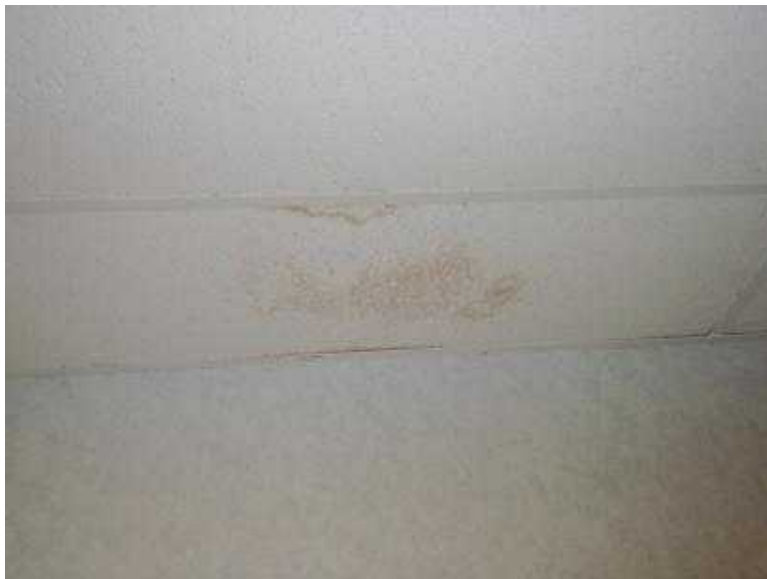
| 4. | <input type="checkbox"/> | <input type="checkbox"/> | <input type="checkbox"/> | <input checked="" type="checkbox"/> | <input type="checkbox"/> | Ceilings: Tile BSI noted an old leak with missing portions of tile in the ceiling of the stairwell leading to the roof. BSI also noted a water stain at the fifth floor ceiling immediately to the right of the elevator. The roof was evaluated using Infrared Thermal Imaging cameras and all stains were found to be inactive. |

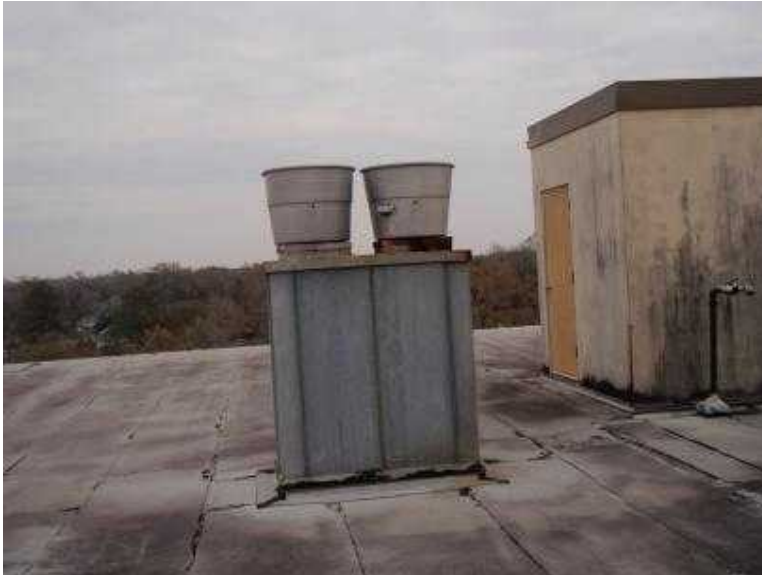
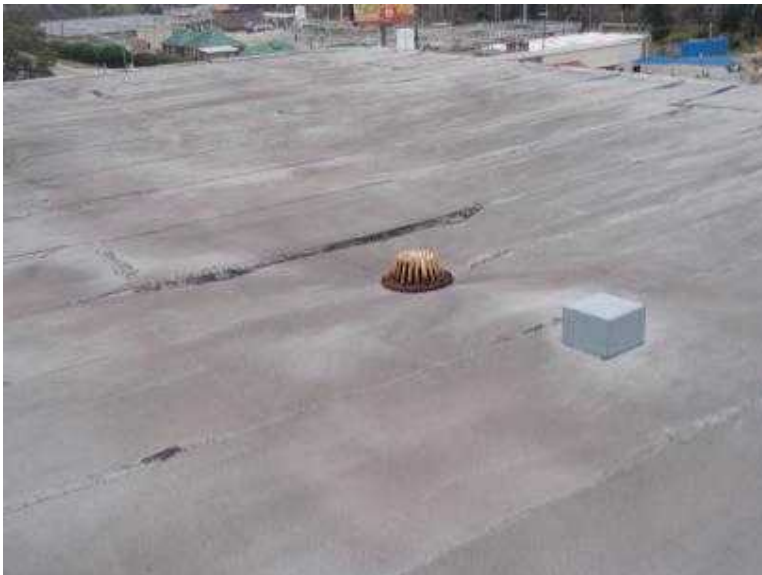
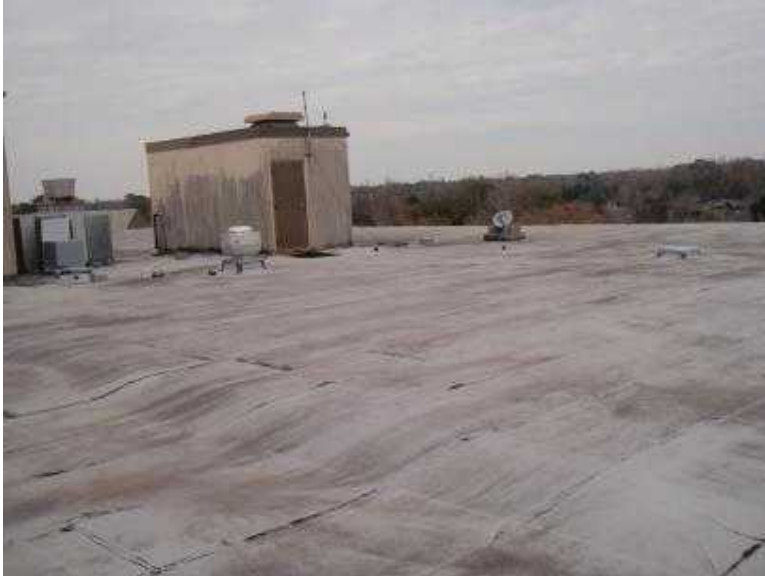
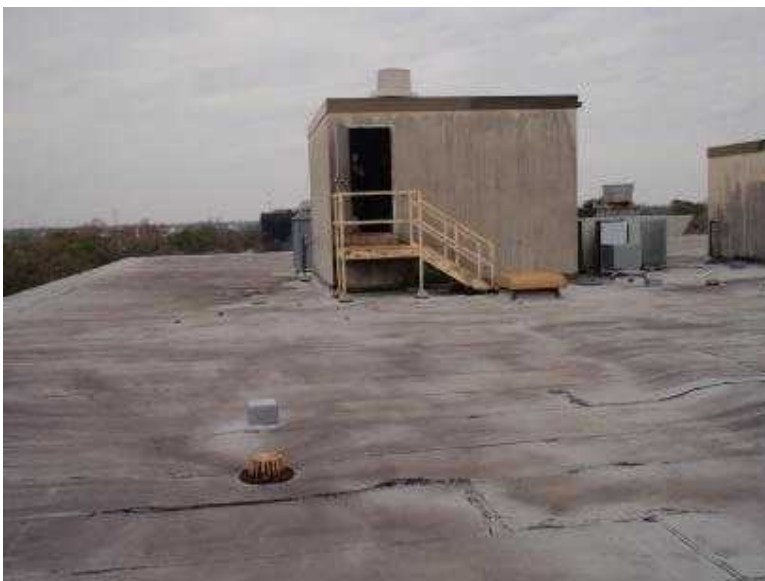
3. Material: Rolled asphalt This roofing system has been replaced recently (within the past six years) and is well sloped to the roof drains. The roof was photographed on 12-27-2012 and showed no standing water at the time. Small pockets of pooling water were noted after the heavy rain on 12-28-2012; this is common and largely unavoidable, and the roof appears to be in very good condition as Infrared Imaging shows no signs of active roof leaks. BSI returned to the roof on the final day of the inspection (12-29-2012) to find only a few areas with standing water. The roof is in good overall condition.

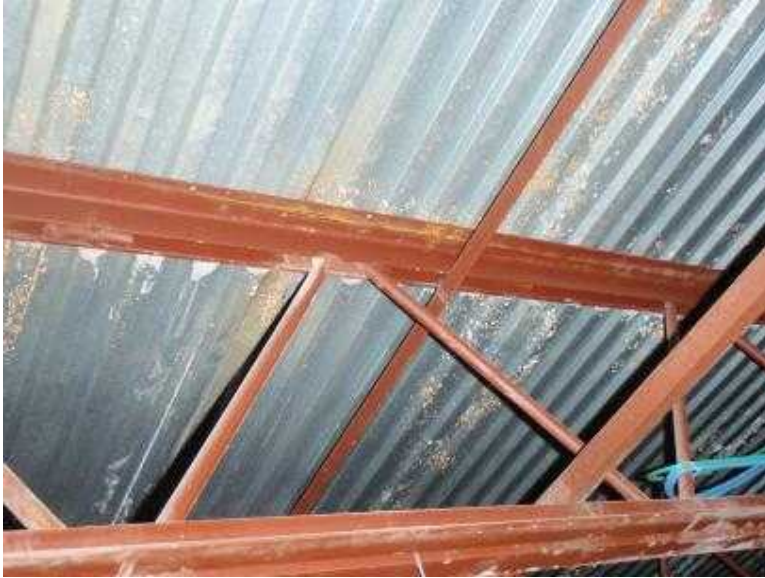
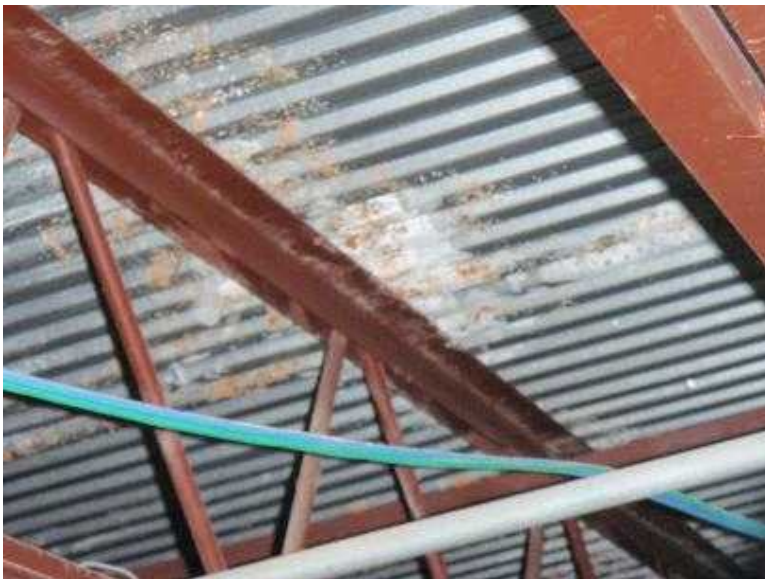
4. Roof under decking Metal Many areas of the under side of the roof have rust indicating that the old roofing leaked in many different areas. All of these areas were tested and found to be inactive at this time.

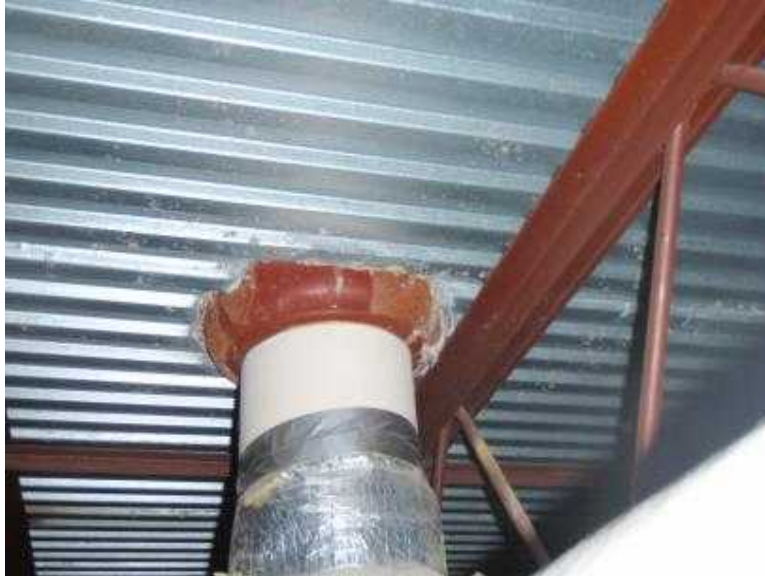
11. Roof Drains Metal Previous leaking is noted at several of the roof drains. All are inactive at this time; likely due to the newer roof installation.

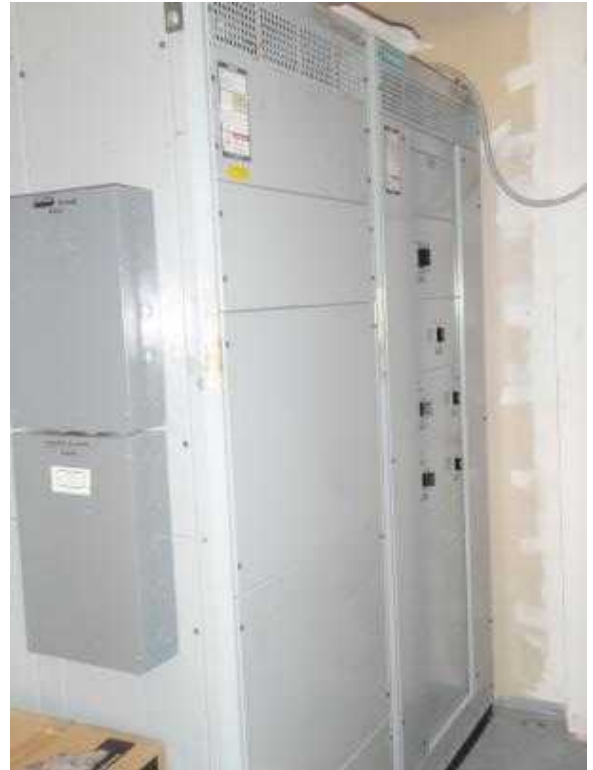
26. Breakers: Copper Bolt On
Circuit #26 was hot;
overheated breakers
noted, evaluation by a
licensed electrician is
recommended.

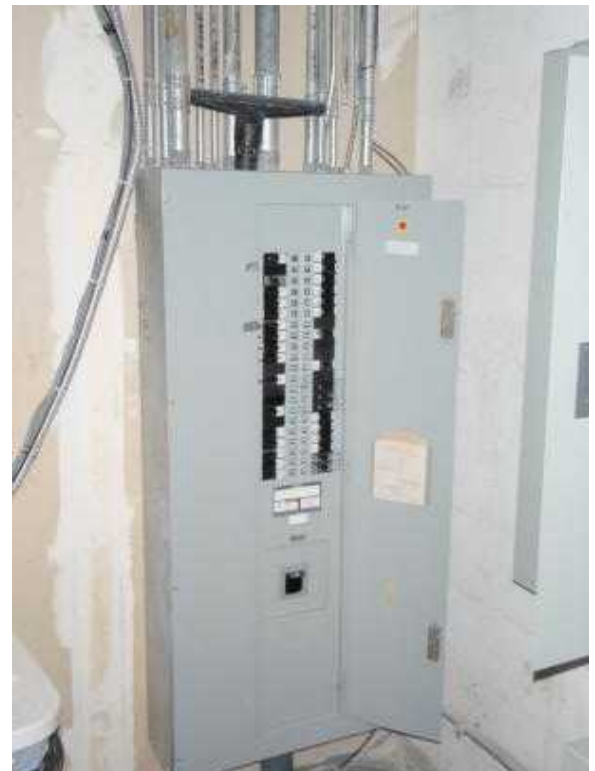
First Floor Electrical Room - L-1 Electric Panel

32. Breakers: Copper Bolt On Circuit #2, 4, 22, 24, and 26 was hot; overheated breakers noted, evaluation by a licensed electrician is recommended to determine the cause of these over-loaded breakers or if the breaker dissimilar metal OL strips have become weak.

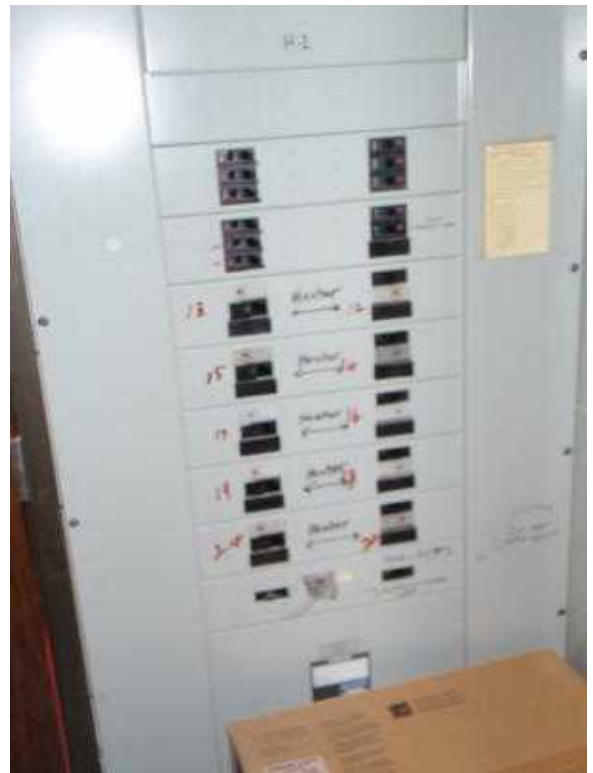
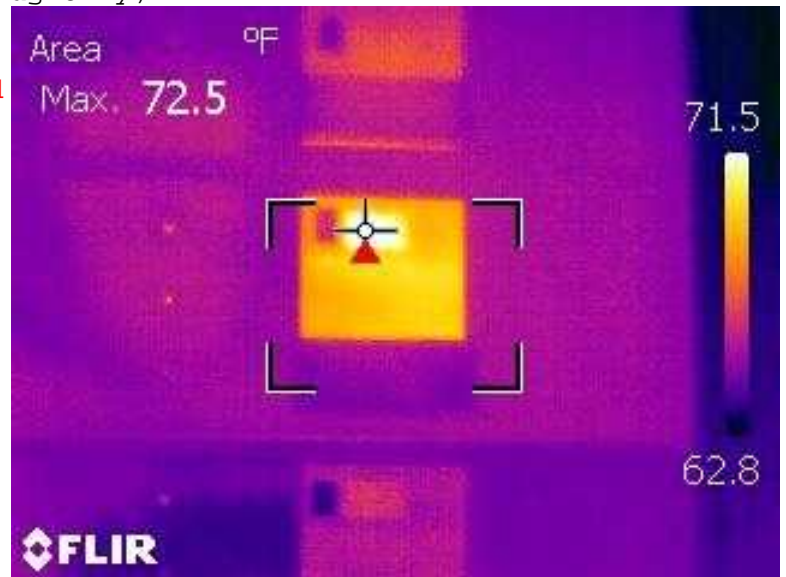
44. Breakers: Copper Bolt On
The circuit breaker for Heater VAV #12 is hot and overloaded; troubleshoot and further evaluate to correct.

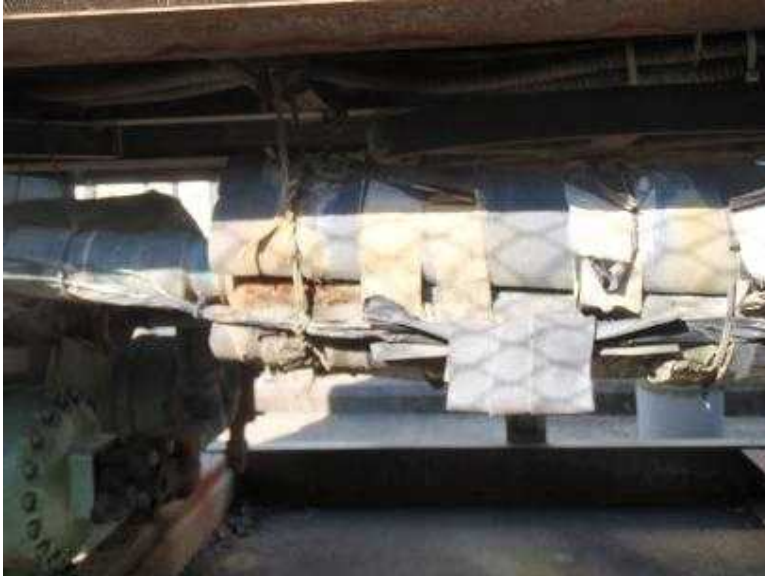
71. A/C System Operation: Not in operation at time of this inspection due to the buildings HVAC load. The gauges and coils of the second chiller are inoperable and or in very poor condition and are recommended to be replaced. The original (older) chiller is only used during high demands for cooling when the primary (new) chiller cannot keep up with the buildings cooling load. The older unit is in poor condition and has a high operating cost; BSI suggests that replacement should be expected in the very near future.

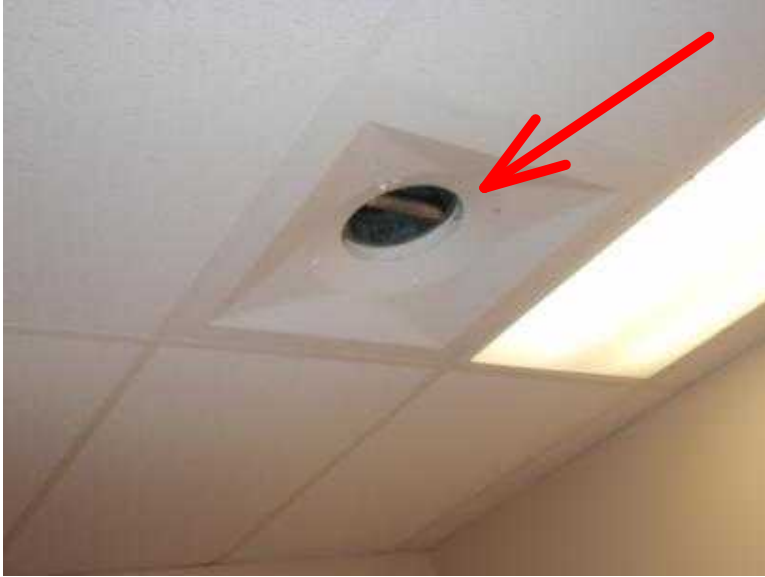
89. Exposed Ductwork: Rigid metal insulated ducts with flexible ducts
Replace the missing diffuser grills at the supply drops on the 5th floor back left side offices. Resecure and seal all ducts at the register connection in the plenums throughout the building.

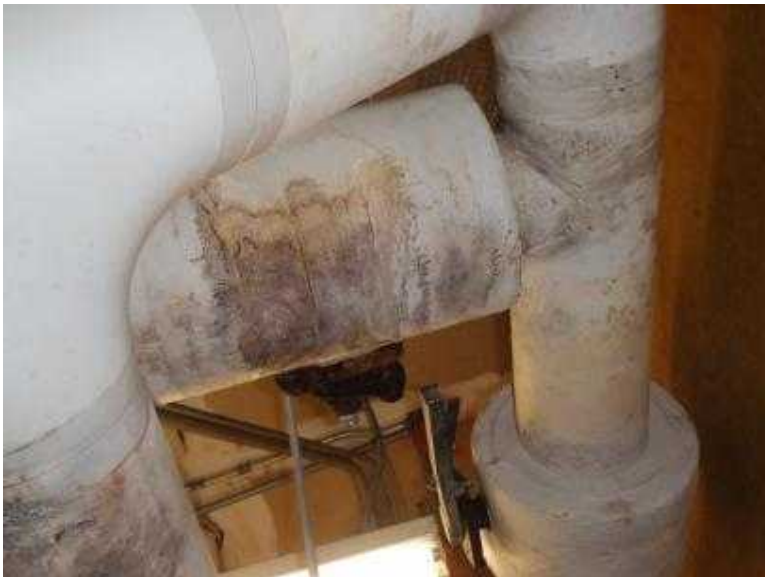
90. Chill Water Piping Insulated Rigid Piping **Correct the leaking at the chill water piping in varies locations in the mechanical rooms. A qualified contractor is recommended to further evaluate and repair.**

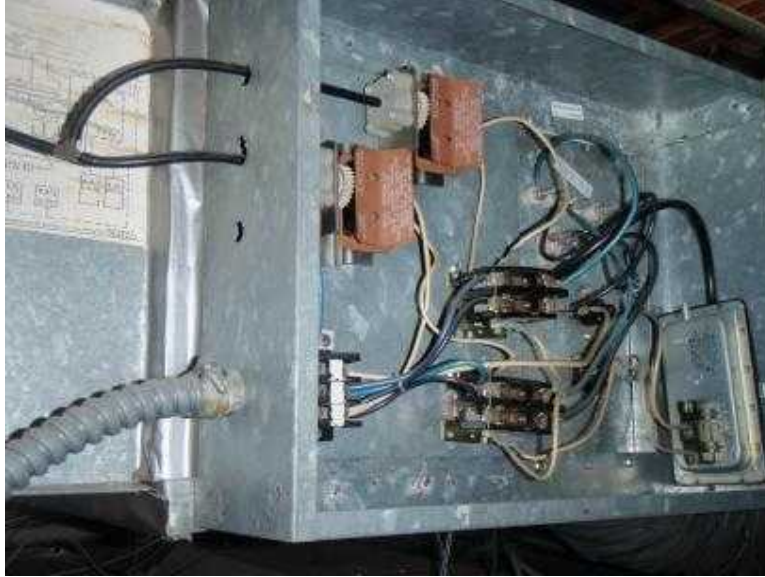
10. Controls: Limit switch Many of the VAV boxes have been opened and left that way for repairs and adjustments. The building maintenance mechanic was called throughout the day to manually adjust many of the VAV's in various office areas.

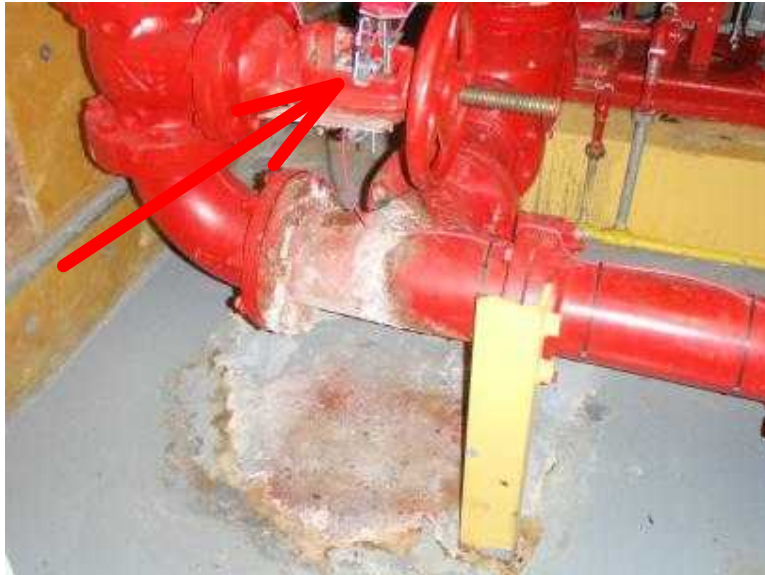
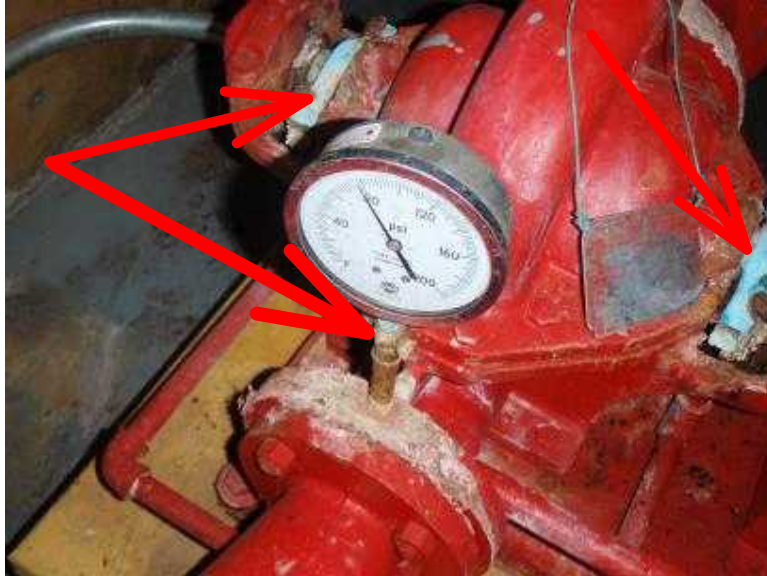
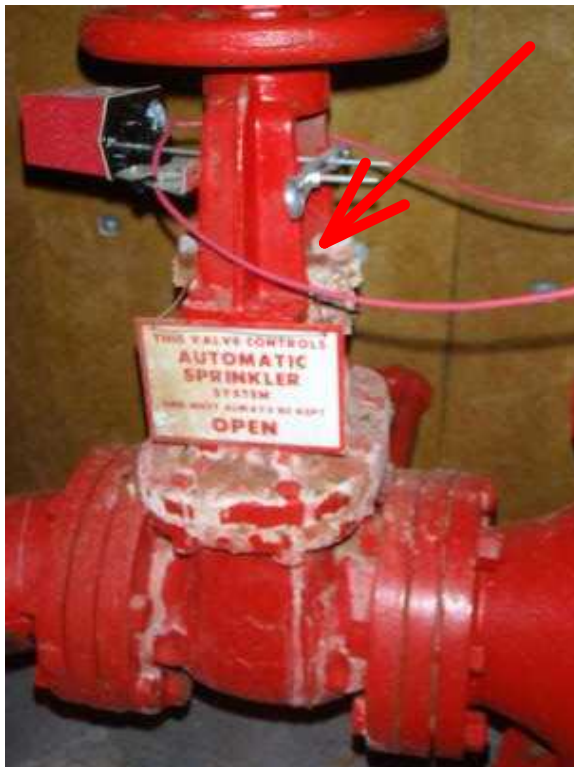
| 7. | <input type="checkbox"/> | <input type="checkbox"/> | <input type="checkbox"/> | <input type="checkbox"/> | <input checked="" type="checkbox"/> | Sprinkler / Fire Supression System Building Sprikler System Although BSI does not test this system several issues and problems were noted from the visual inspection. BSI recommends an inspection be performed by a sprinkler testing company as well as repairs of all defects. Leaking is noted at the first floor mechanical room at several connections. |

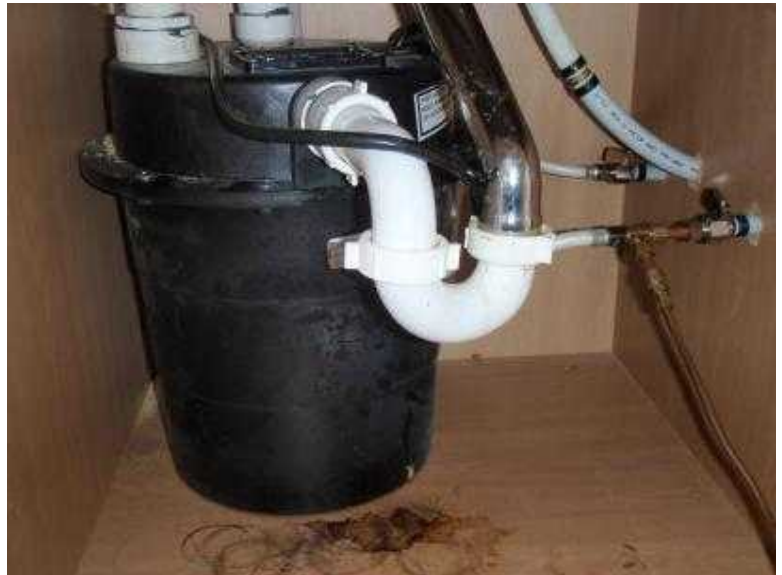
The sump trap drains slowly. It is clogged and needs cleaning; repair.

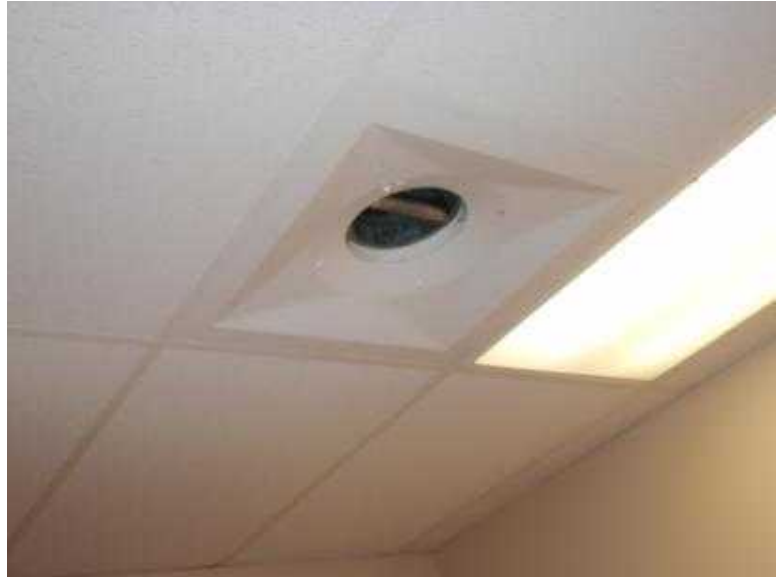
- 50. Cabinets: Wood
- 51. Ceiling: Tile
- 52. Walls: Sheetrock
- 53. Floor: Vinyl
- 54. Doors: Wood
- 55. Windows:
- 56. HVAC Source: Central AC
Replace the missing register grill/ diffuser.

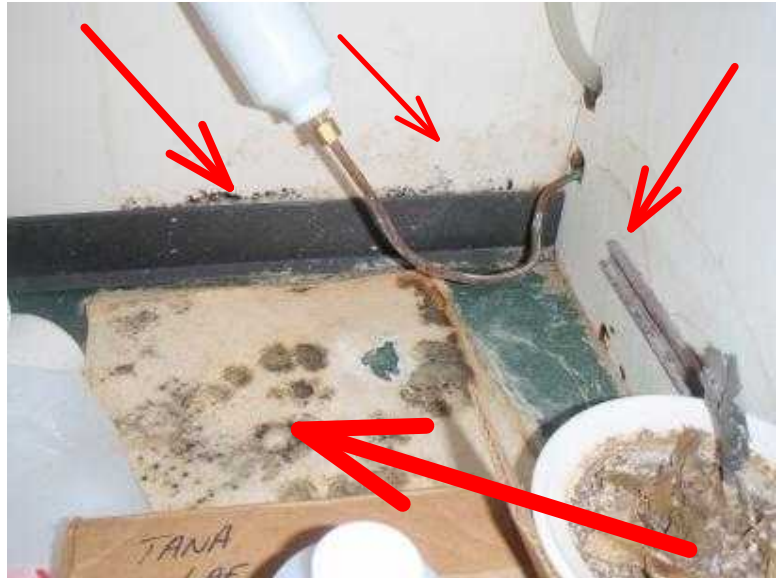
149. Walls: Sheetrock Water damage at the back sheetrock wall underneath the sink was noted. Visible mold was noted at the water damaged area. Remove and replace all water and mold damaged building materials.

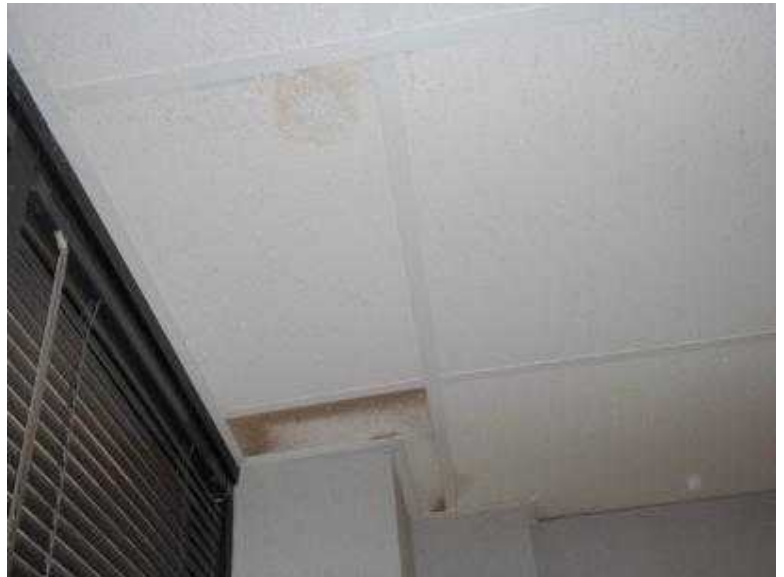
4th Floor Office Space

28. Closet: Single Storage
29. Ceiling: Tile **BSI noticed water stains on five ceiling tile in the back right office. None of these stains appear to be active at this time. These appear to have been caused from a previous window leak coming from the fifth floor.**

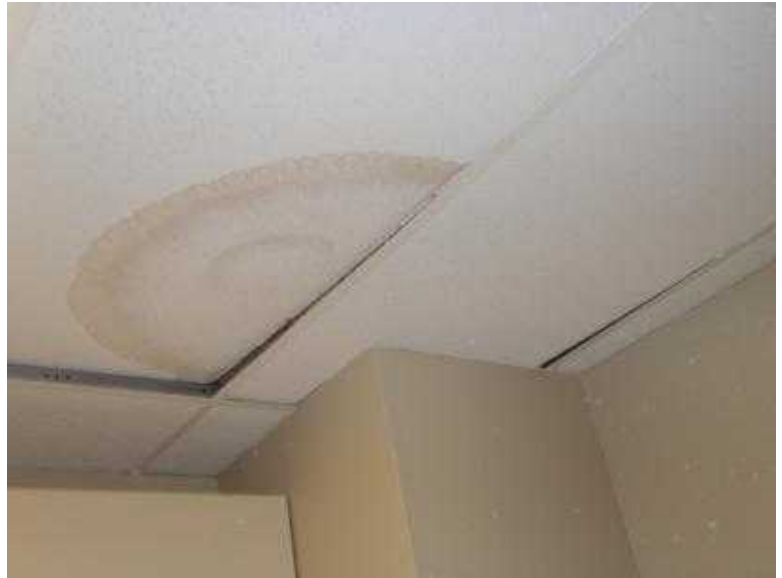
38. Ceiling: Tile Replace all water damaged tile and other porous building materials. The stains at the ceiling tile have all been found to be from previous leaking that is inactive at the time of this inspection.

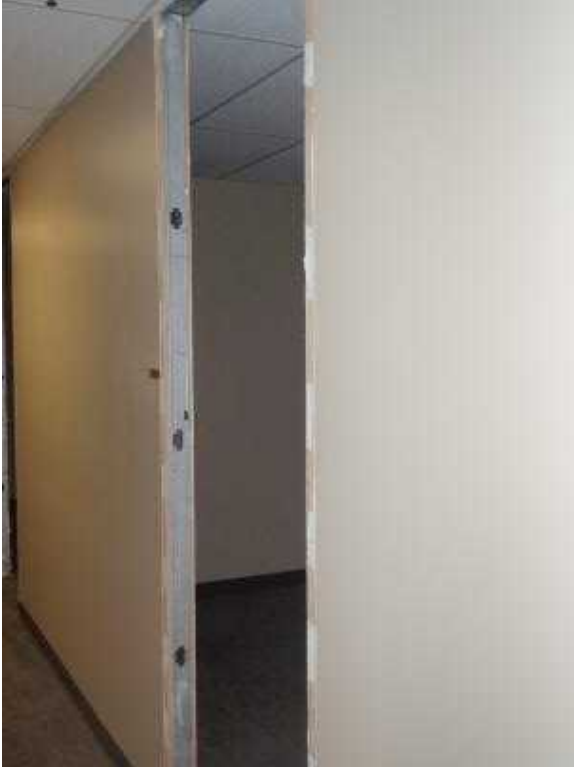
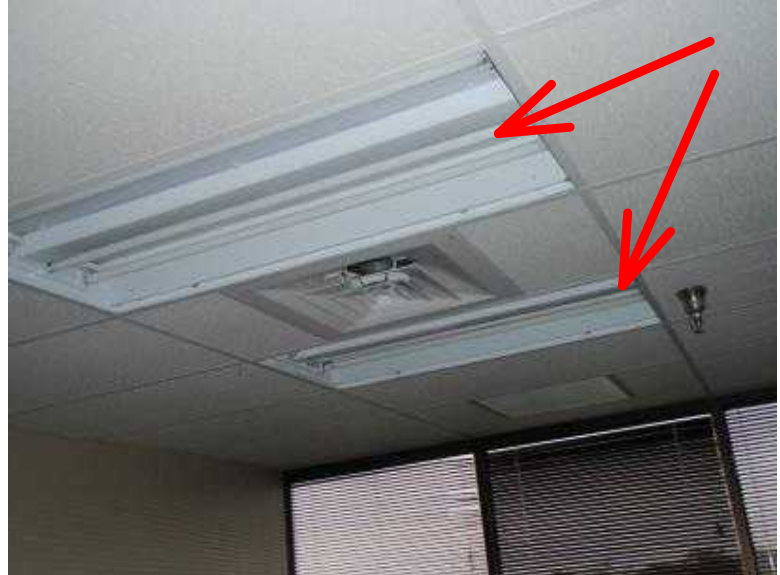
46. Several of the office spaces on the 5th floor (the back left area) are being remodeled. Doors are not on their hinges, light covers were noted missing, and some door casings were missing. Much of the carpet is stained and many of the areas will need to be painted. Repair/ finish renovations of this area.

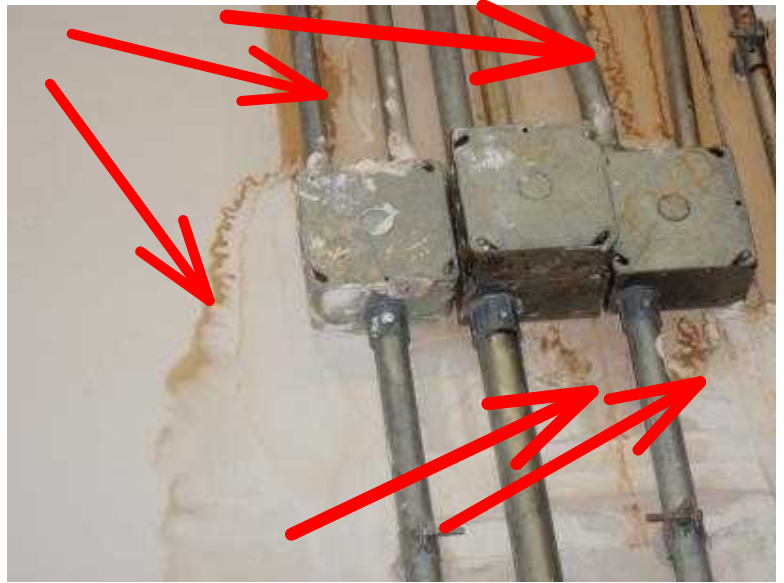
2. Walls: Sheetrock Stains were noted from previous leaking at the walls on the second floor electrical closet.

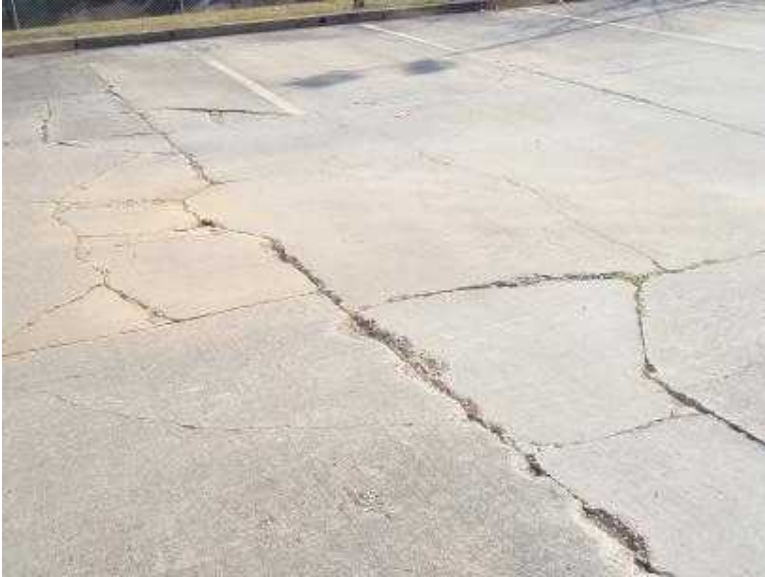
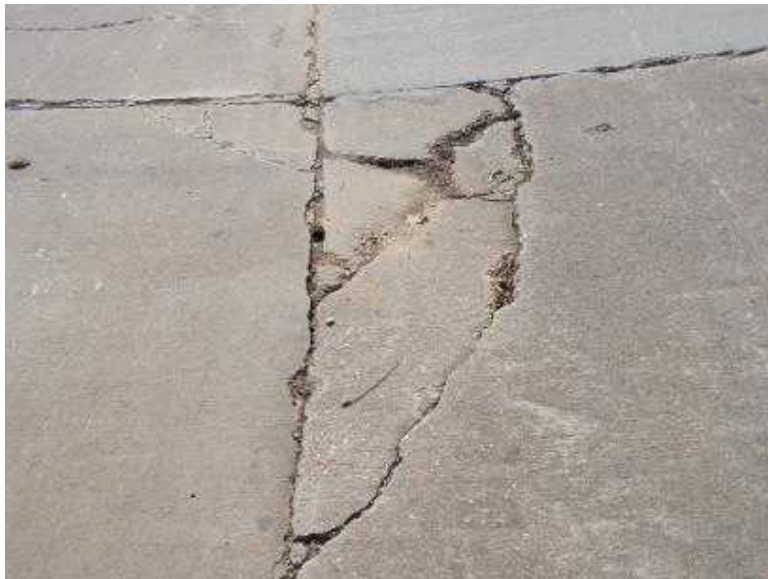
1. Driveway: Concrete Cracking and breaking are noted at the parking lot driveway areas; they are uneven. Some areas are lower than others.

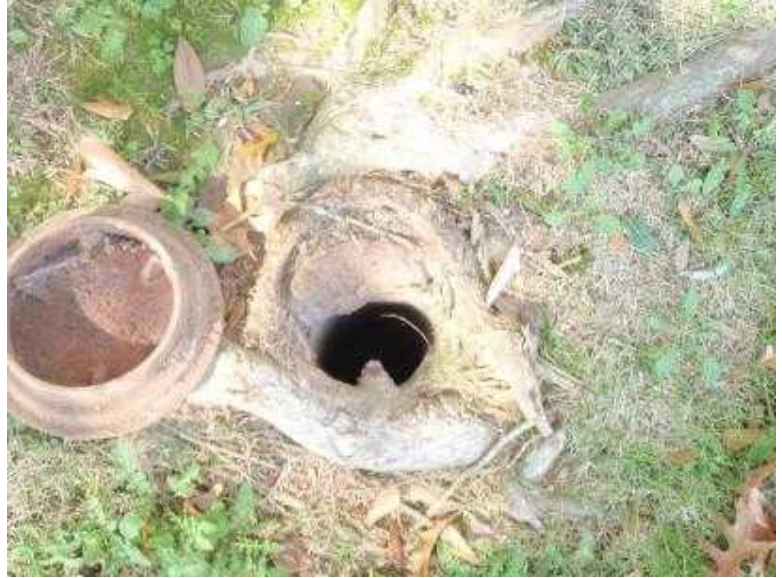
3. Vegetation: Shrubs/Weeds/ Trees The right side of the building has a plumbing drain pipe that the tree roots have grown around. BSI recommends monitoring this to prevent damage to the pipe.

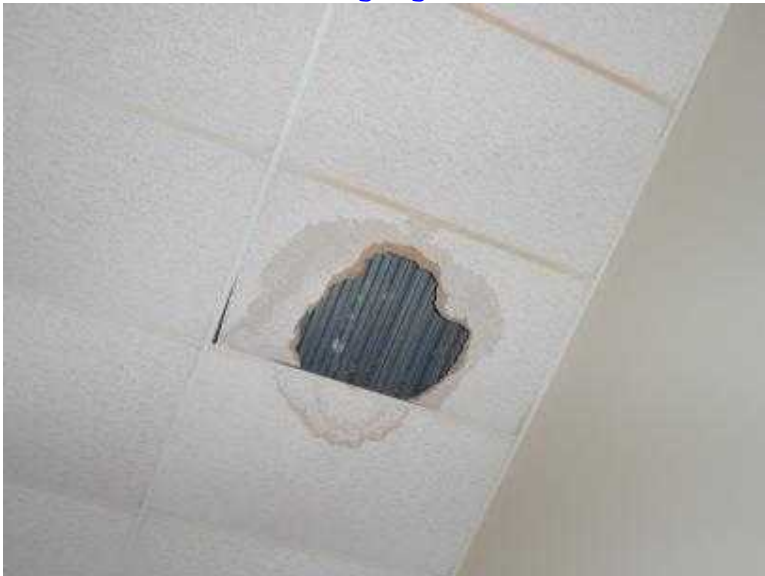
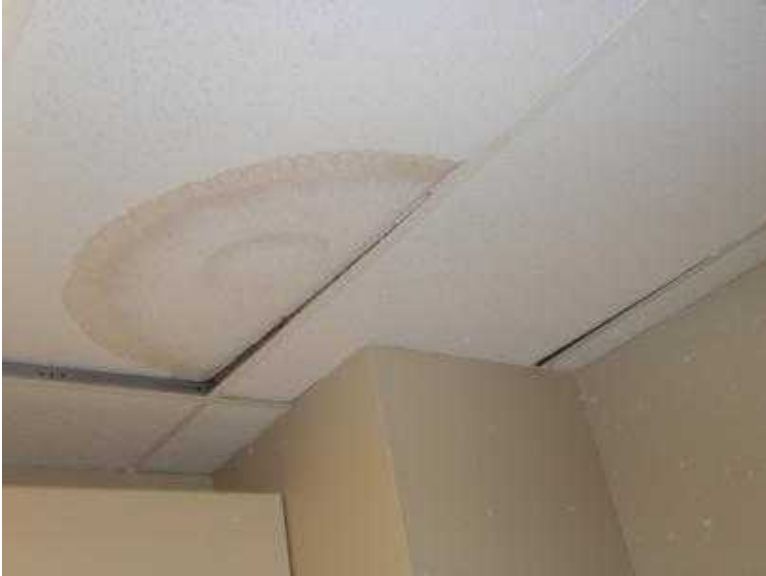
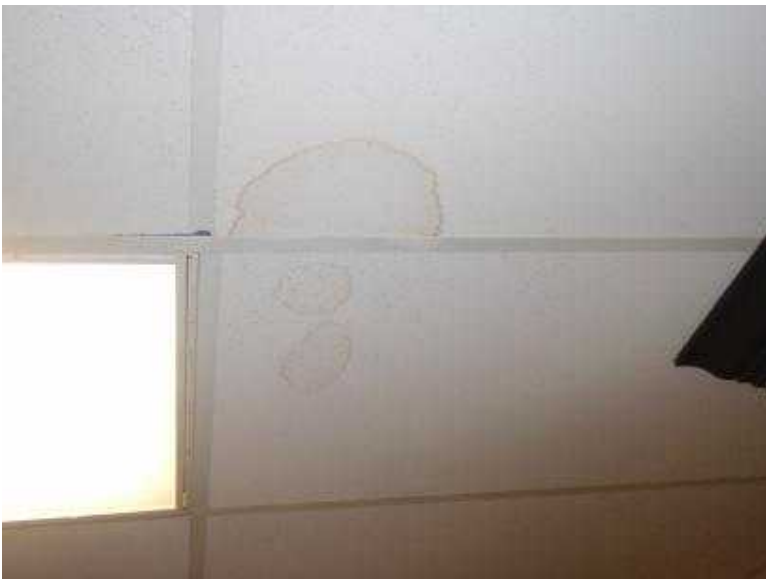
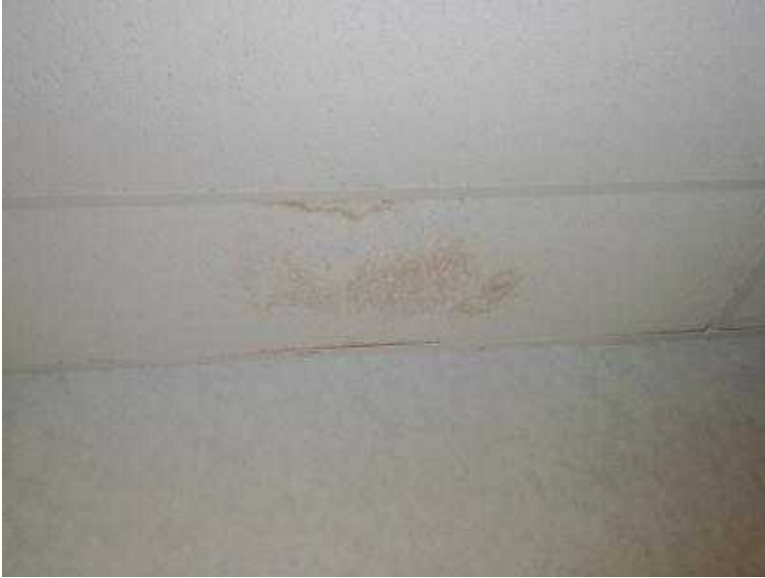
5. Ceilings: Tile BSI noted an old leak with missing portions of tile in the ceiling of the stairwell leading to the roof. BSI also noted a water stain at the fifth floor ceiling immediately to the right of the elevator. The roof was evaluated using Infrared Thermal Imaging cameras and all stains were found to be inactive.

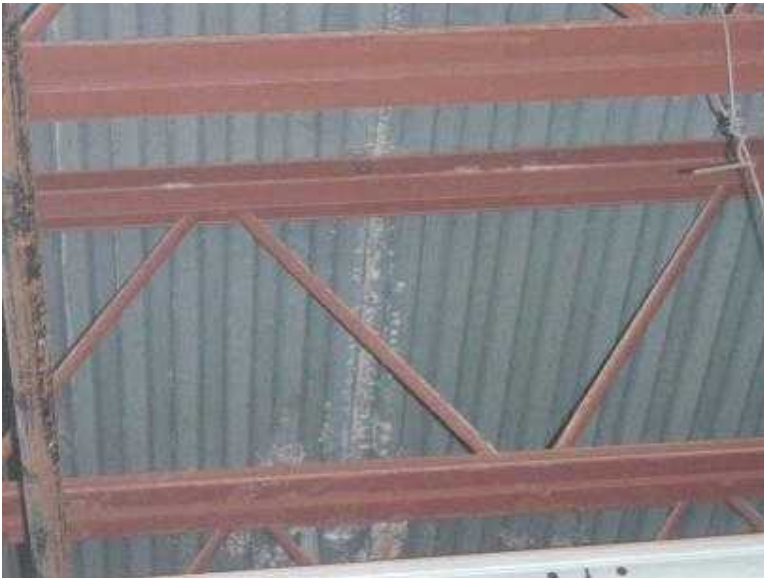
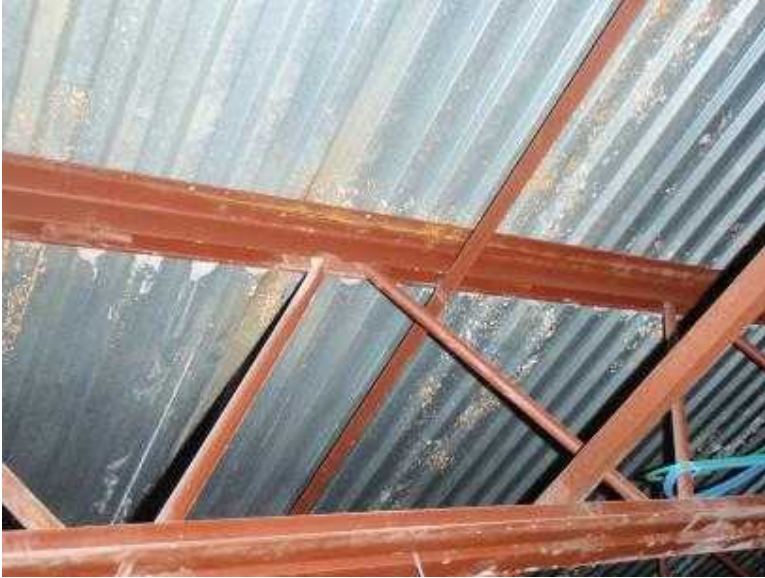
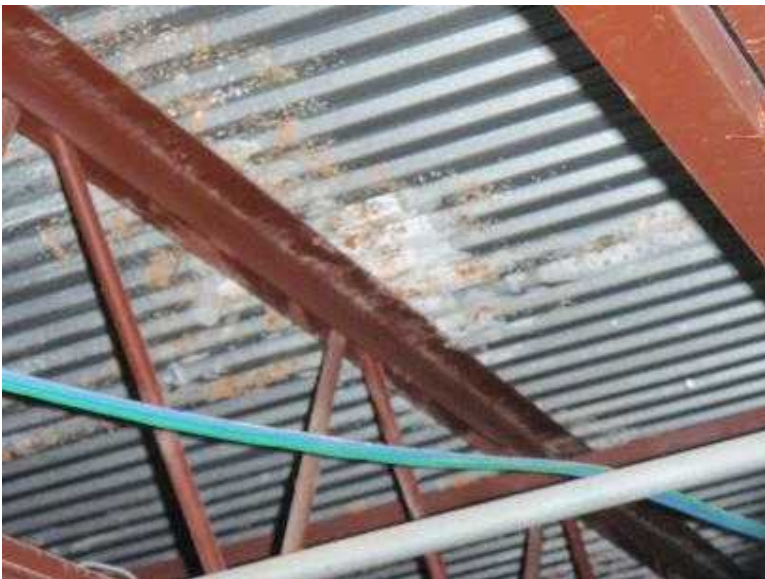
6. Main roof of building Roof Surface Roof under decking Metal Many areas of the under side of the roof have rust indicating that the old roofing leaked in many different areas. All of these areas were tested and found to be inactive at this time.

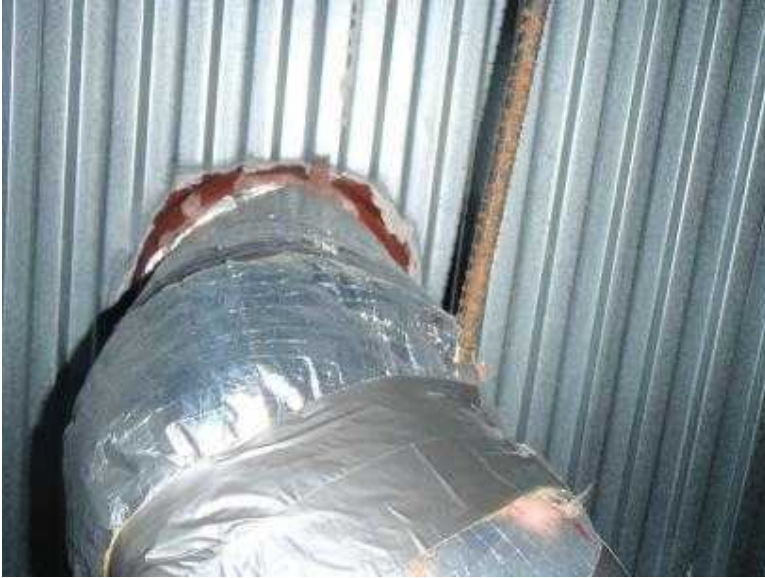
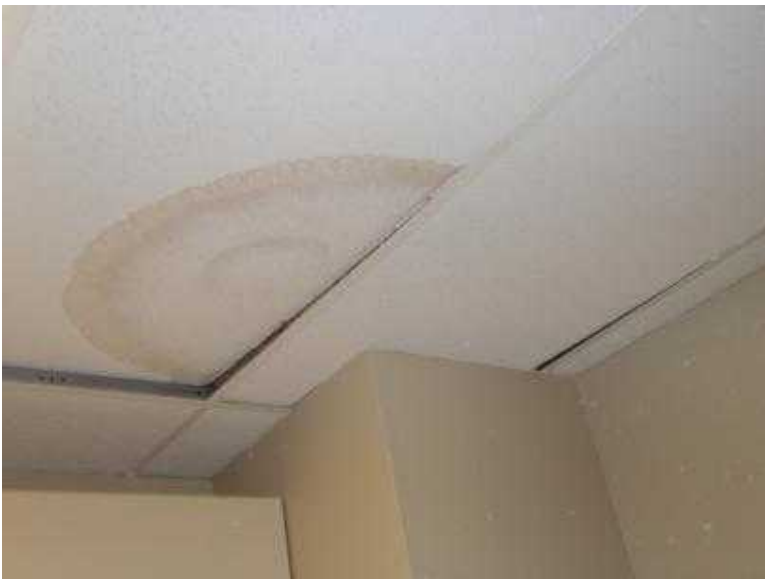
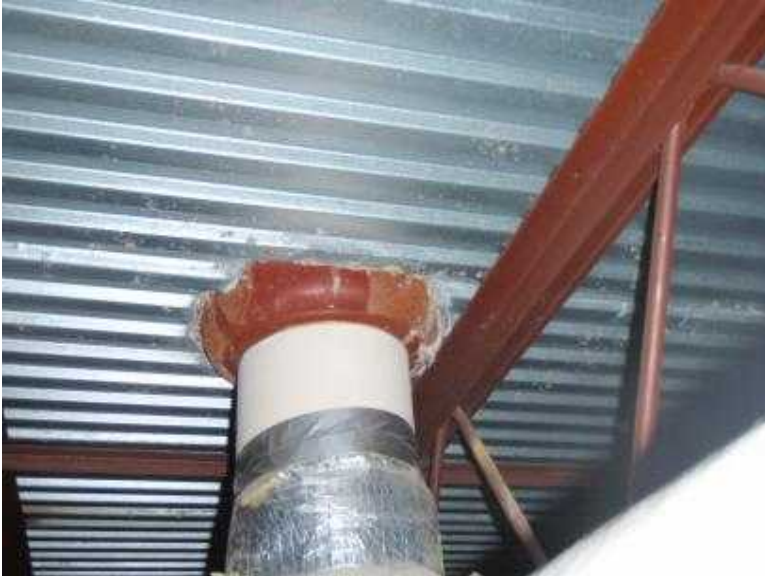
7. Roof Drains Metal Previous leaking is noted at several of the roof drains. All are inactive at this time; likely due to the newer roof installation.

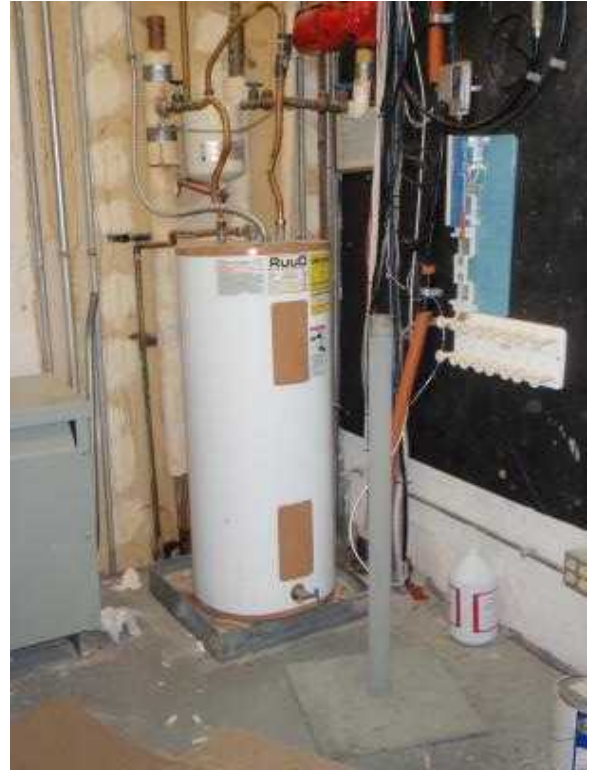
15. Water Heater #1 Second floor mechanical closet Water Heater
Water Heater Operation: Functional at time of inspection The HVAC unit has exceeded its' manufacturer's designed life (12 Years). Although units can last years beyond their life expectancy, BSI would recommend to budget accordingly. BSI recommends obtaining a home warranty due to the age of the unit.

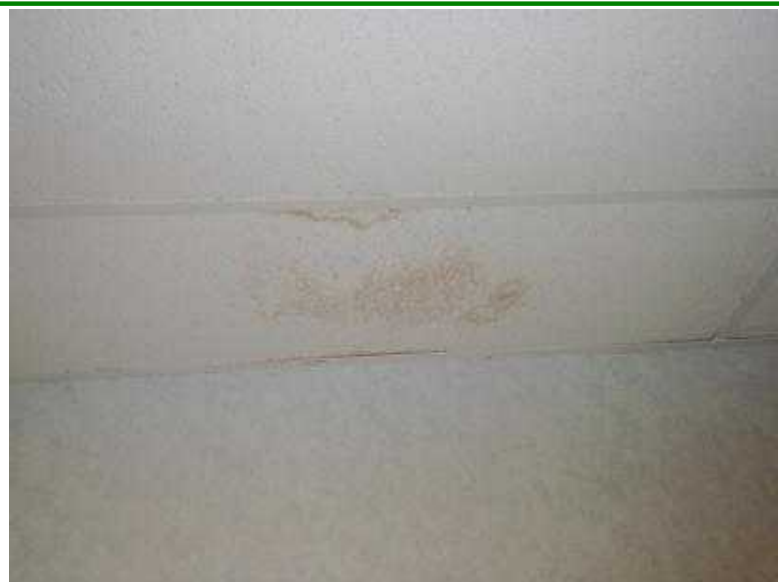
16. First Floor Womens Bathroom Ceiling: Tile
Water stains were noted in the back left corner.

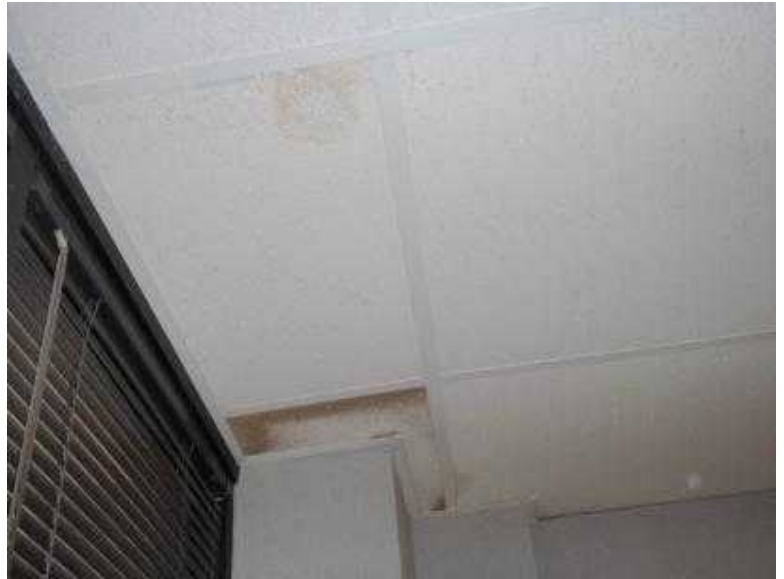
20. 4th Floor Office Space Ceiling: Tile BSI noticed water stains on five ceiling tile in the back right office. None of these stains appear to be active at this time. These appear to have been caused from a previous window leak coming from the fifth floor.

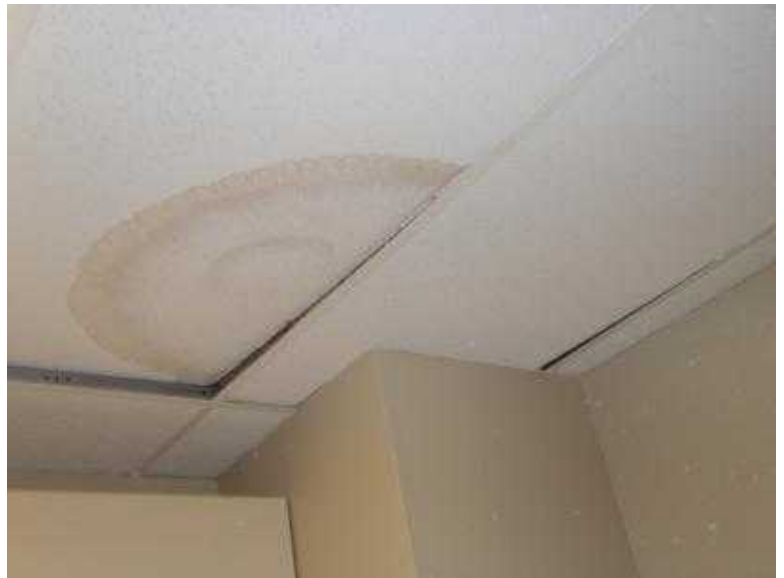
21. 5th Floor Office Space Ceiling: Tile Replace all water damaged tile and other porous building materials. The stains at the ceiling tile have all been found to be from previous leaking that is inactive at the time of this inspection.
