Bayou State Inspections

Page 2 of 83
sample office building report

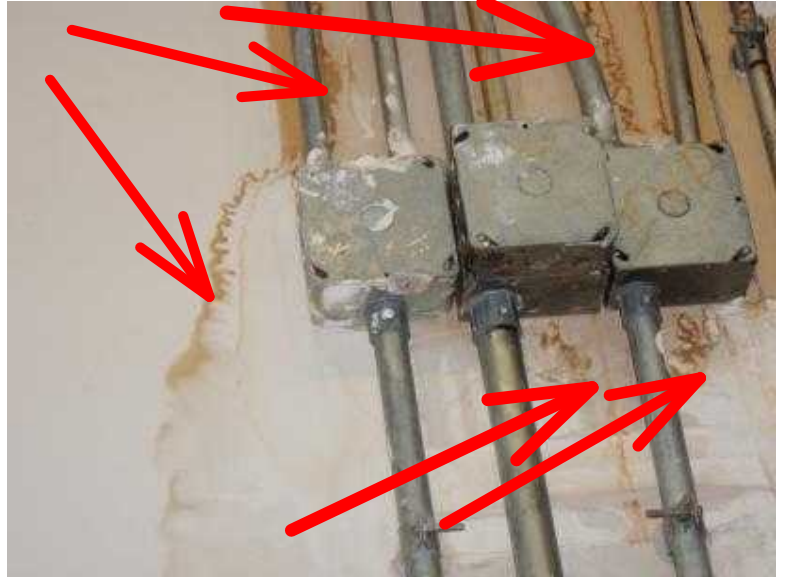
22. 1st through 5th Floor Janitor's Room Walls:
Sheetrock Stains were noted from
previous leaking at the walls on the
second floor electrical closet.

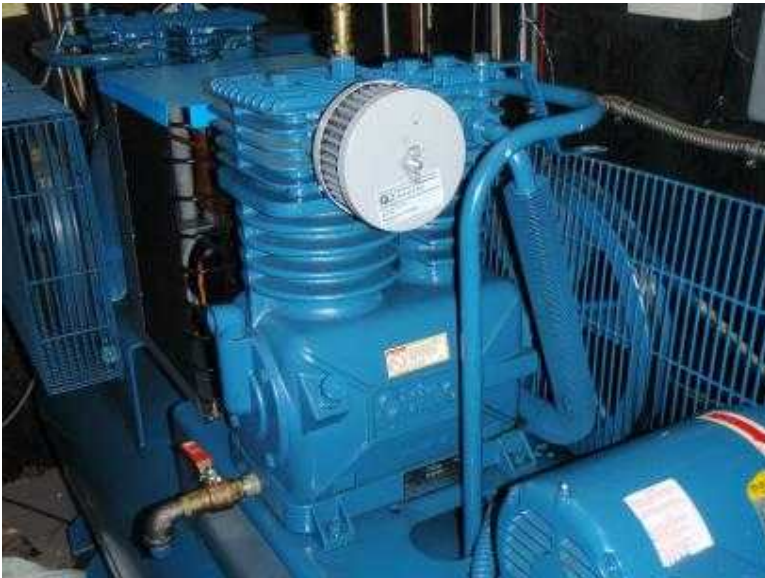
1. Behind Main Entrance Back Wall in Lobby Elevator Elevator: Otis Although BSI is not responsible for inspecting the elevator units at this time, we did note leaking oil at the equipment at the roof penthouse. BSI highly recommends servicing and re-inspecting the elevator units. Additionally, BSI found that the left side elevator is inoperable at this time awaiting parts and a circuit board. Repair the elevator unit and components.
2. Behind Main Entrance Back Wall in Lobby Elevator Building Air Compressor Quincy The building air compressor is in good overall condition and functioning properly at this time. However a small oil leak is noted at the compressor pumps that should be repaired as a general maintenance item. This should also be put on the buildings weekly checklist.

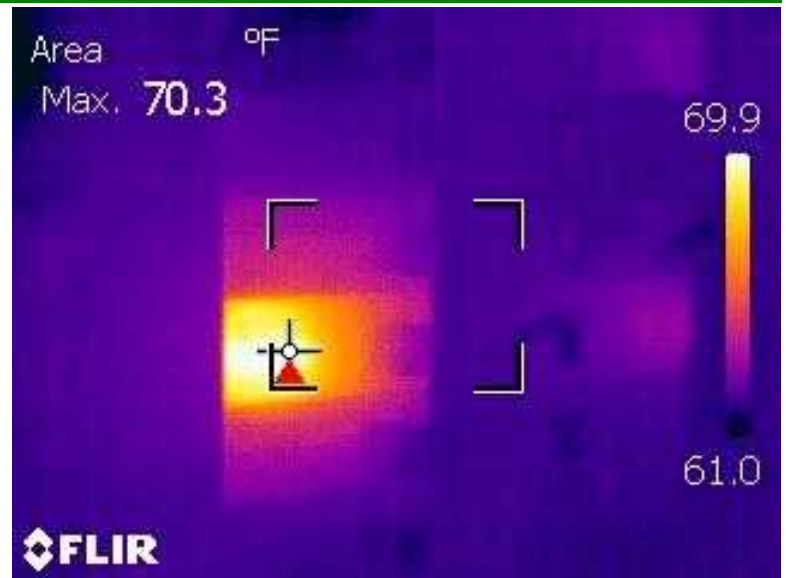
3. First Floor Electrical Room - XL-1 Electric Panel
Breakers: Copper Bolt On **Circuit #26** was hot; overheated breakers noted, evaluation by a licensed electrician is recommended.

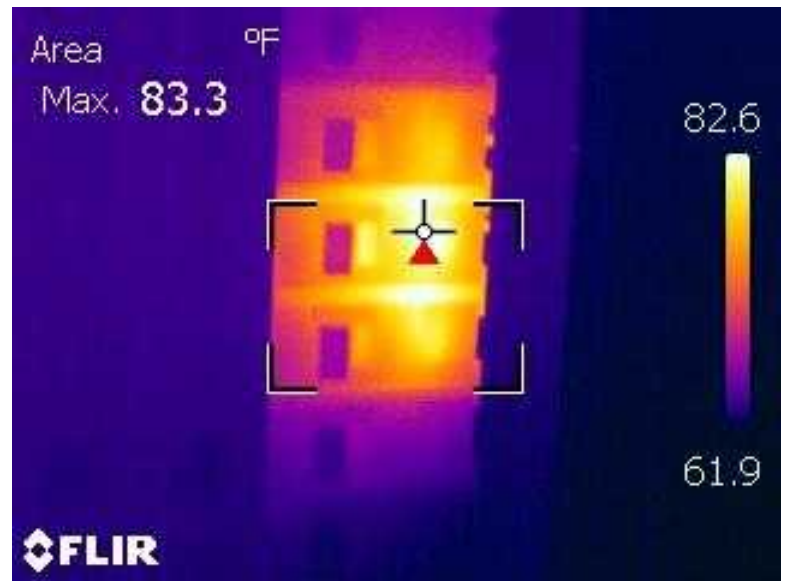
4. First Floor Electrical Room - L-1 Electric Panel Breakers: Copper Bolt On Circuit #2, 4, 22, 24, and 26 was hot; overheated breakers noted, evaluation by a licensed electrician is recommended to determine the cause of these over-loaded breakers or if the breaker dissimilar metal OL strips have become weak.

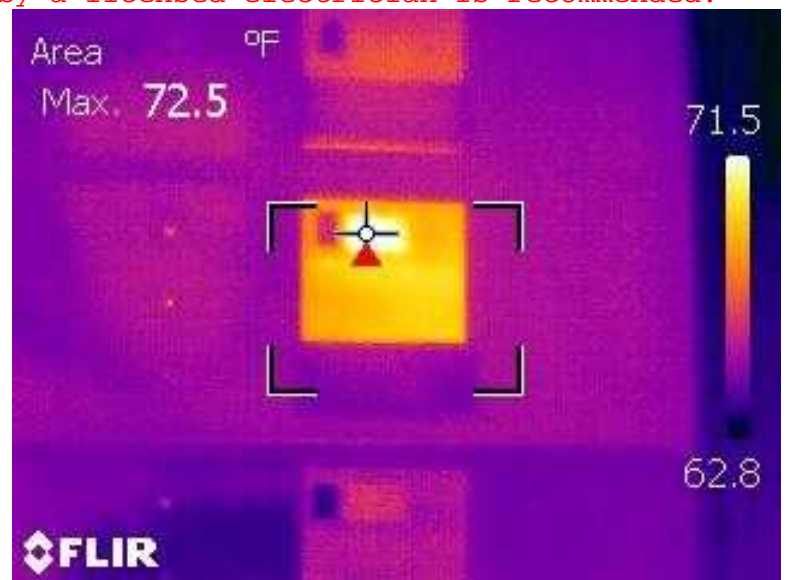
5. First Floor Electrical Room - 1-G Electric Panel Breakers: Copper Bolt On Circuit #11 was hot; overheated breakers noted, evaluation by a licensed electrician is recommended.
6. First Floor Electrical Room - H-1 Electric Panel Breakers: Copper Bolt On The circuit breaker for Heater VAV #12 is hot and overloaded; troubleshoot and further evaluate to correct.

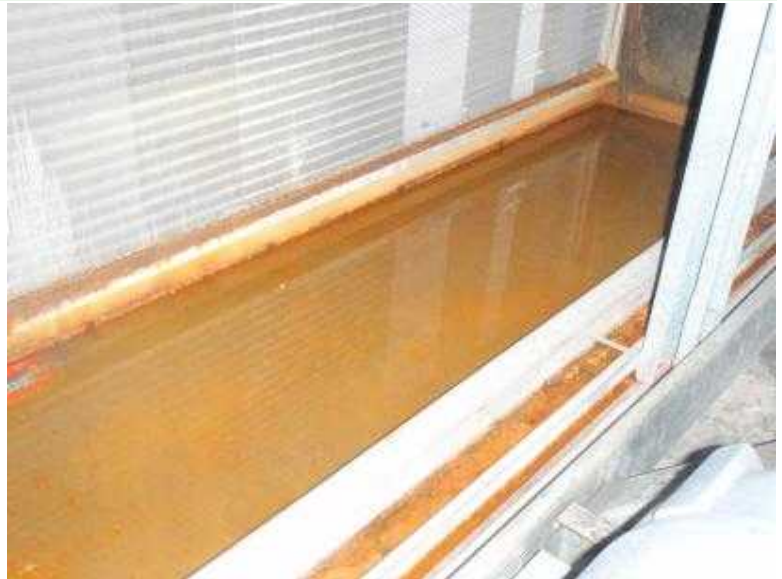
Condensate Removal: Metal to floor drain

The coils were cleaned recently. The primary drain pan, however, was clogged and full of water, sediment, and debris. This is likely due to cleaning out the coils without also cleaning the pan so that the debris from the dirty coils stayed in the pan and clogged it up. BSI recommends unclogging and cleaning the pan and ensuring that, in the future, the pan be cleaned as well as the coils. Due to the rust in the pan it may need to be re-coated to prevent leaking at rusted areas; at this time BSI did not note any visual leaking of the secondary drain pan.

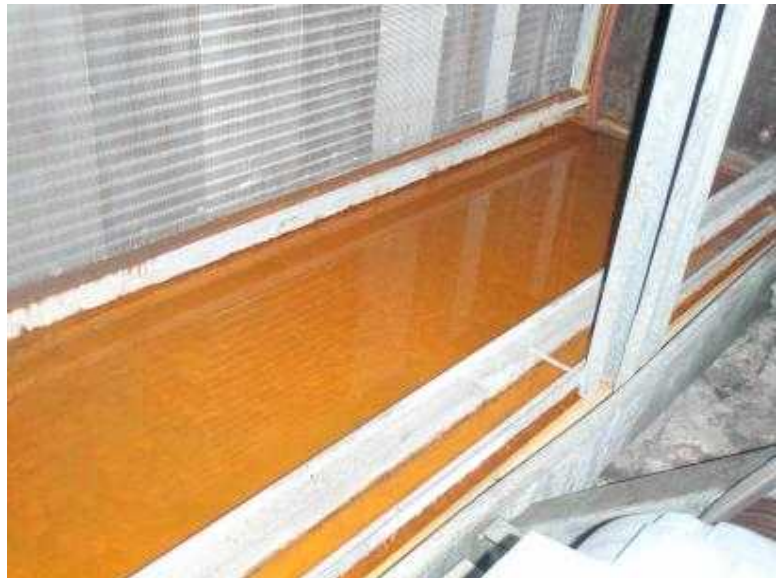
13. Mechanical Room Fourth Floor AC System

The coils were cleaned recently. The primary drain pan, however, was clogged and full of water, sediment, and debris. This is likely due to cleaning out the coils without also cleaning the pan so that the debris from the dirty coils stayed in the pan and clogged it up. BSI recommends unclogging and cleaning the pan and ensuring that, in the future, the pan be cleaned as well as the coils. Due to the rust in the pan it may need to be re-coated to prevent leaking at rusted areas; at this time BSI did not note any visual leaking of the secondary drain pan.

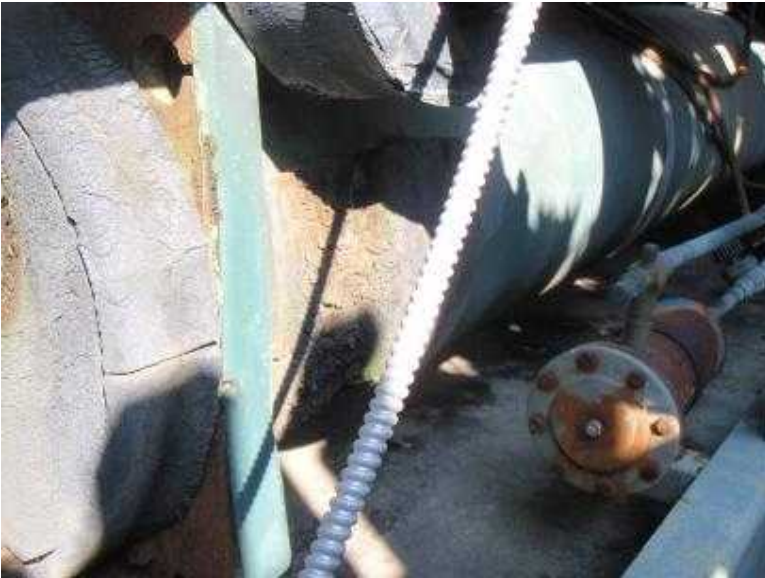
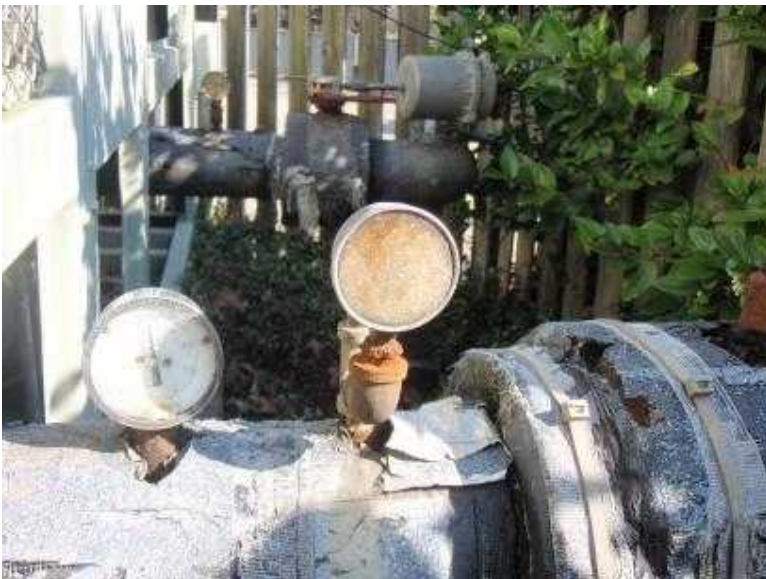
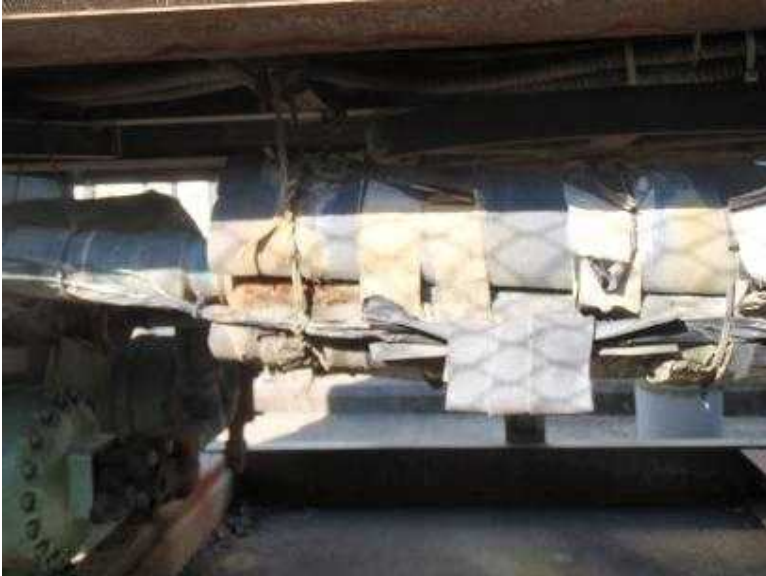
15. Chiller #2 AC System A/C System Operation: Not in operation at time of this inspection due to the buildings HVAC load The gauges and coils of the second chiller are inoperable and or in very poor condition and are recommended to be replaced. The original (older) chiller is only used during high demands for cooling when the primary (new) chiller cannot keep up with the buildings cooling load. The older unit is in poor condition and has a high operating cost; BSI suggests that replacement should be expected in the very near future.

| | <u>Low</u> | <u>High</u> |
|---|---|---|
| Chiller #2 AC System A/C System Operation: The gauges and coils of the second chiller are inoperable and or in very poor condition and are recommended to be replaced. The original (older)chiller is only used during high demands for cooling when the primary (new) chiller cannot keep up with the buildings cooling load. The older unit is in poor condition and has a high operating cost; BSI suggests that replacement should be expected in the very near future. | \$ 85000 | \$ 108000 |

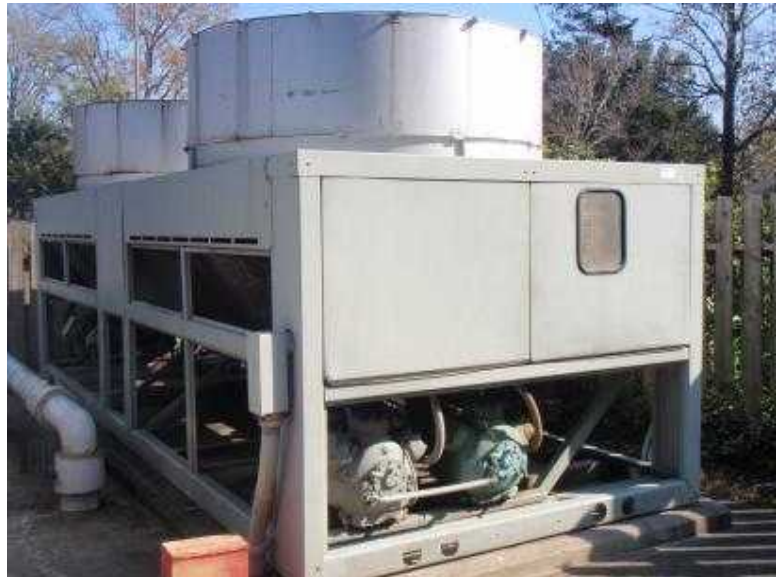
16. Chiller #2 AC System Exterior Unit: Pad mounted
The gauges and coils of the second chiller are inoperable and or in very poor condition and are recommended to be replaced. The original (older) chiller is only used during high demands for cooling when the primary (new) chiller cannot keep up with the buildings cooling load. The older unit is in poor condition and has a high operating cost; BSI suggests that replacement should be expected in the very near future.

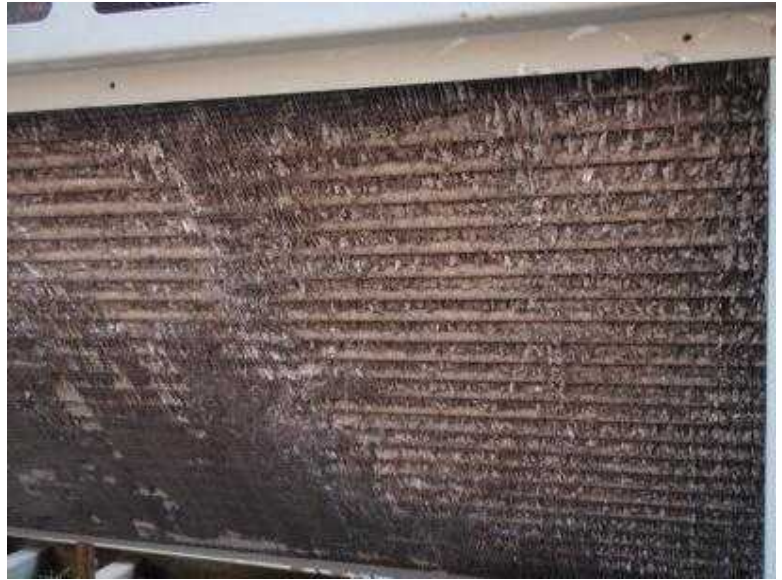
17. Chiller #2 AC System Visible Coil: Copper core with aluminum fins The coils of the older chiller unit are in very poor condition such that cleaning or trying to repairs them would likely result and further damage. A qualified air conditioning contractor is recommended to evaluate and estimate repairs.

| | <u>Low</u> | <u>High</u> |
|---|---|---|
| Chiller #2 AC System Visible Coil: The coils of the older chiller unit are in very poor condition such that cleaning or trying to repairs them would likely result and | | |

further damage. A qualified air conditioning contractor is recommended to evaluate and estimate repairs.

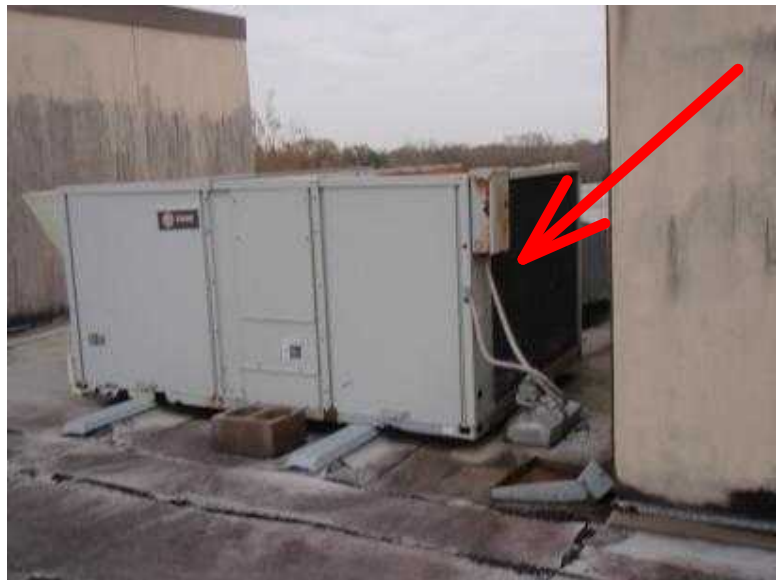
18. Roof Top Unit AC System A/C System Operation: Inoperative, unit appears to have been terminated and no longer in use. BSI recommends replacement or removal of the unit; as it has not been in operation for the past two years according to the building maintenance department. Further evaluation by an HVAC contractor is recommended.

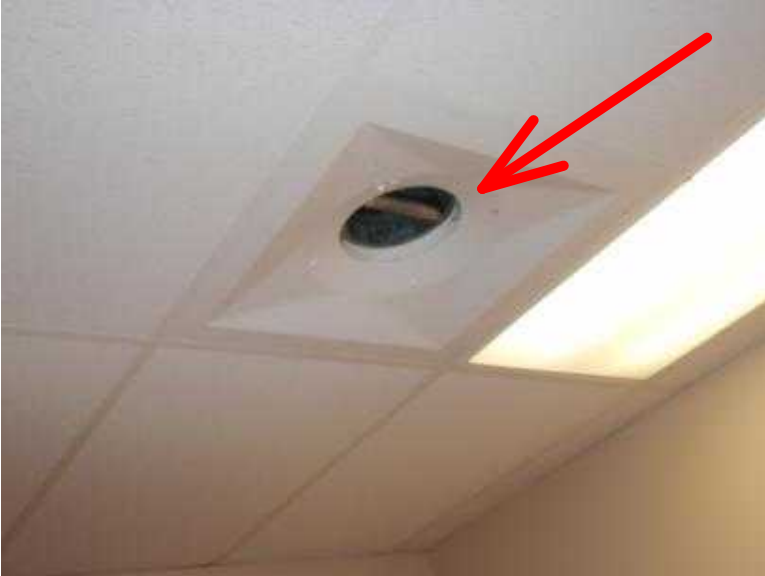
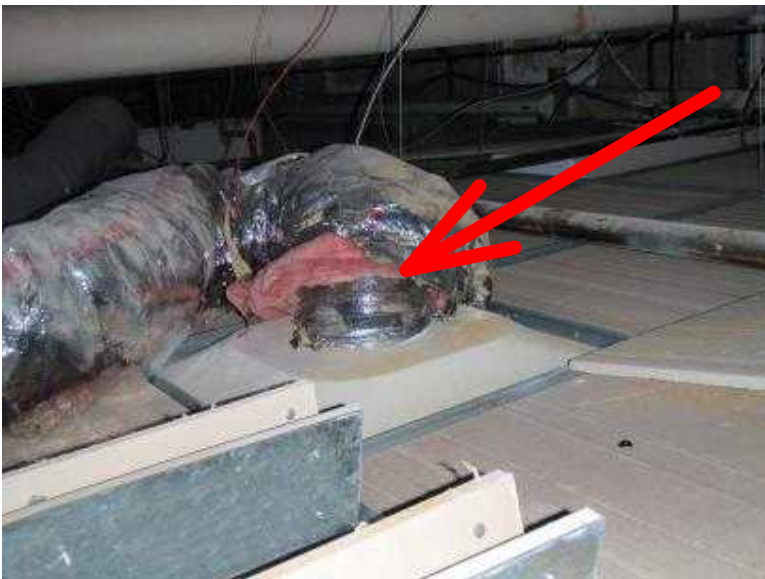
19. Exposed Ductwork: Rigid metal insulated ducts with flexible ducts Replace the missing diffuser grills at the supply drops on the 5th floor back left side offices. Resecure and seal all ducts at the register connection in the plenums throughout the building.

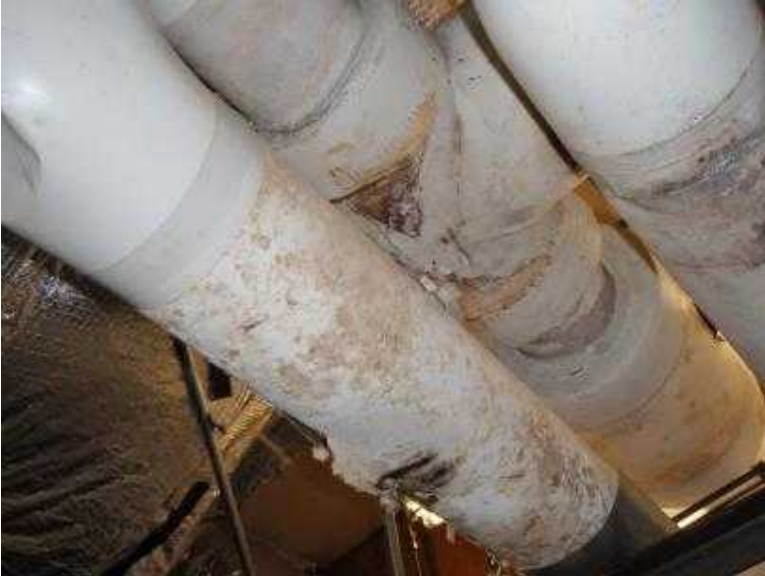
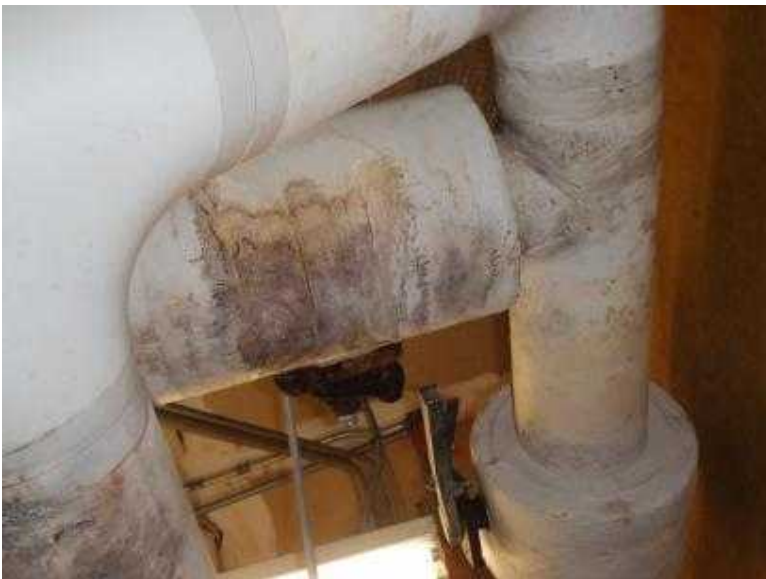
20. Chill Water Piping Insulated Rigid Piping Correct the leaking at the chill water piping in varies locations in the mechanical rooms. A qualified contractor is recommended to further evaluate and repair.

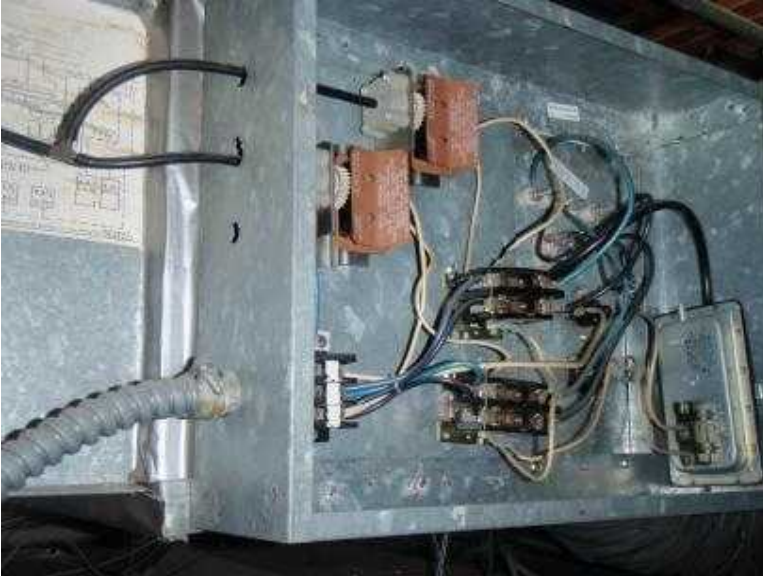
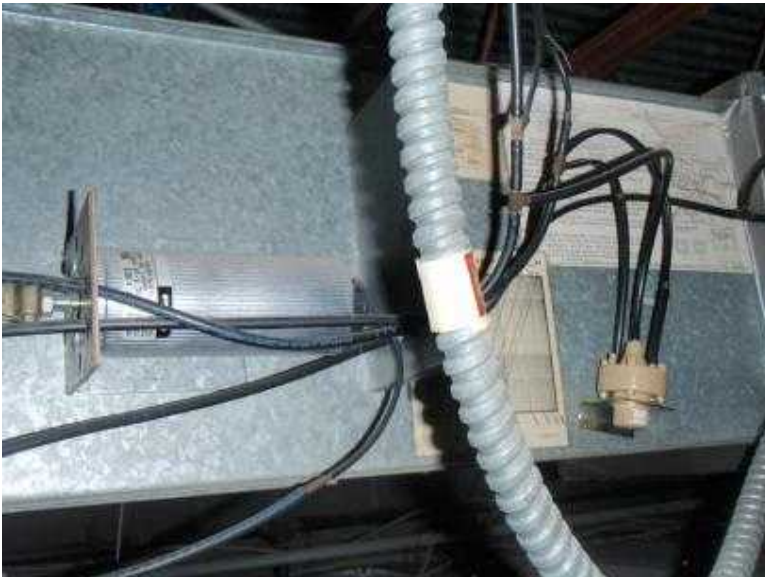
22. First through Fifth Floor Attic Plenum Heating System Controls: Limit switch Many of the VAV boxes have been opened and left that way for repairs and adjustments. The building maintenance mechanic was called throughout the day to manually adjust many of the VAV's in various office areas.

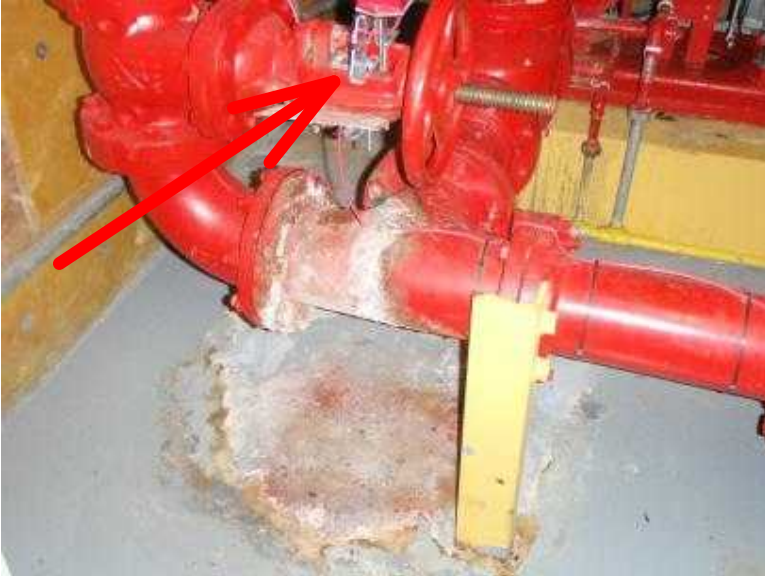
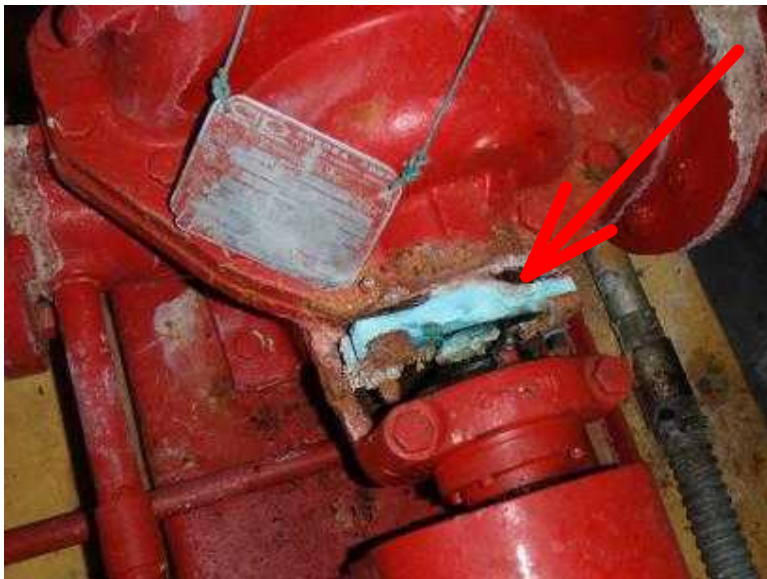
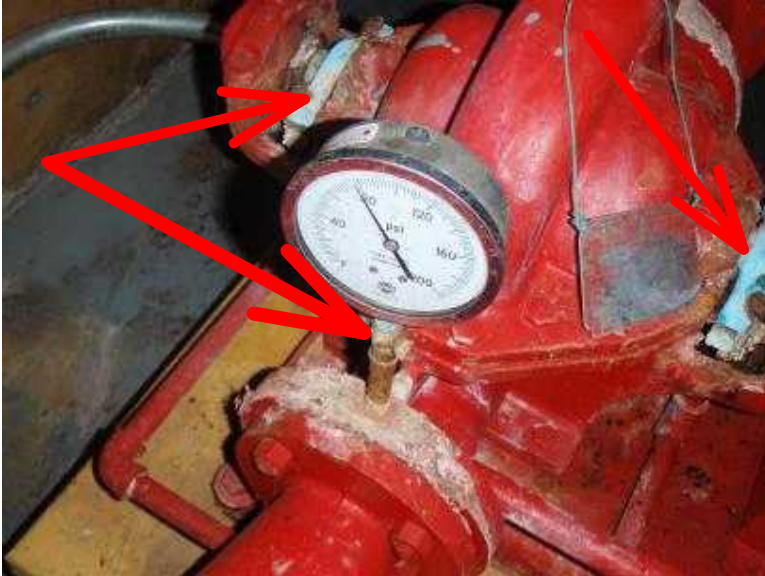
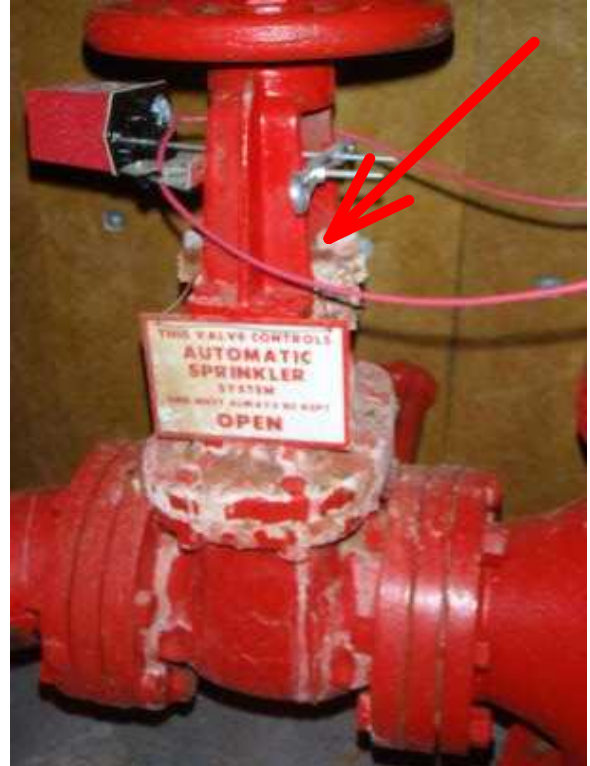
23. Sprinkler / Fire Suppression System Building Sprinkler System Although BSI does not test this system several issues and problems were noted from the visual inspection. BSI recommends an inspection be performed by a sprinkler testing company as well as repairs of all defects. Leaking is noted at the first floor mechanical room at several connections.

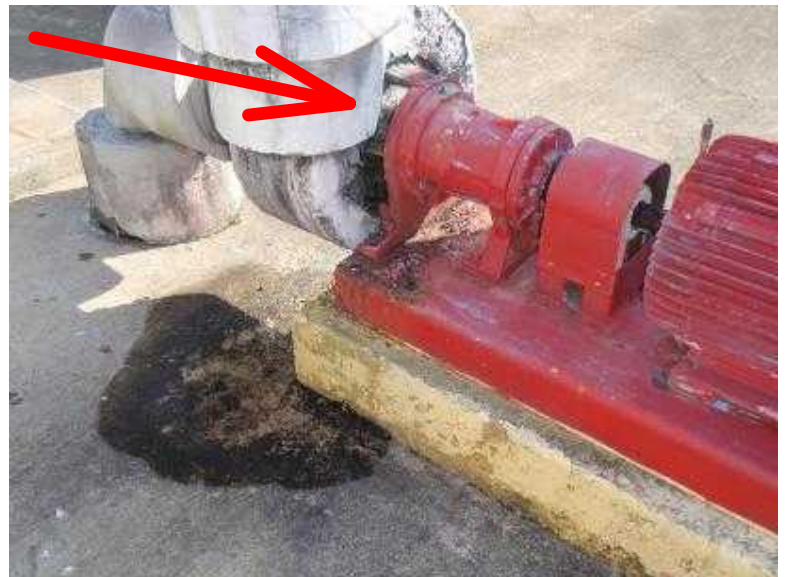
24. Chill Water Pump #1 (Outside Chiller Yard) Water Heater Chilled Water Pump Chill Water Pump #1 The chilled water pump & motor have exceeded the manufacturer's designed life (12 Years). Although units can last years beyond their life expectancy, BSI would recommend to budget accordingly. Repair the leak at pump #1; see photo.

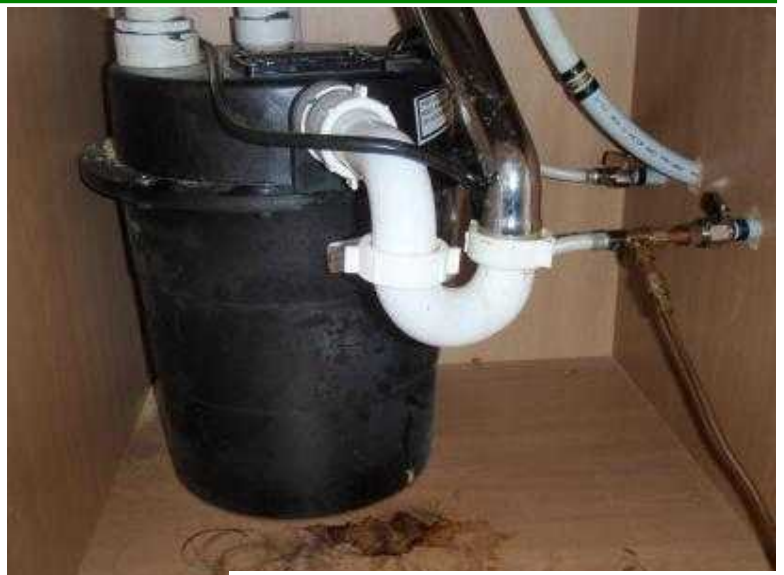
38. Third Floor Lounge Employee Lounge
Plumbing/Fixtures: American Standard faucet with "PVC" P trap **The sump trap drains slowly. It is clogged and needs cleaning; repair.**

| Third Floor Lounge Employee Lounge Plumbing/Fixtures: The sump trap drains slowly. It is clogged and needs cleaning; repair. | \$ 150 | \$ 235 |

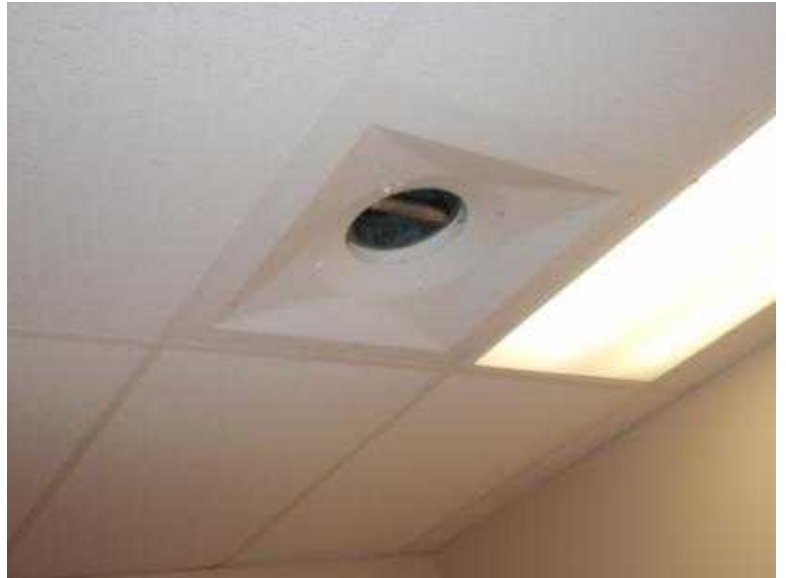
39. Third Floor Lounge Employee Lounge HVAC
Source: Central AC **Replace the missing register grill/ diffuser.**

| Third Floor Lounge Employee Lounge HVAC Source: Replace the missing register grill/ diffuser. | | |

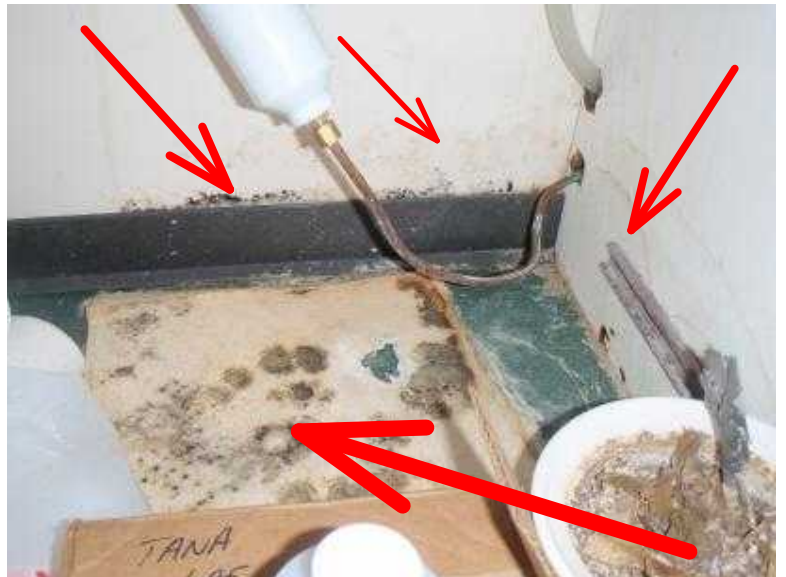
45. Fifth Floor Lounge #2 TANA Employee Lounge
Walls: Sheetrock **Water damage at the back sheetrock wall underneath the sink was noted. Visible mold was noted at the water damaged area. Remove and replace all water and mold damaged building materials.**

Fifth Floor Lounge #2 TANA Employee Lounge Walls: Water damage at the back sheetrock wall underneath the sink was noted. Visible mold was noted at the water damaged area. Remove and replace all water and mold damaged building materials. \$ 650 \$ 1350

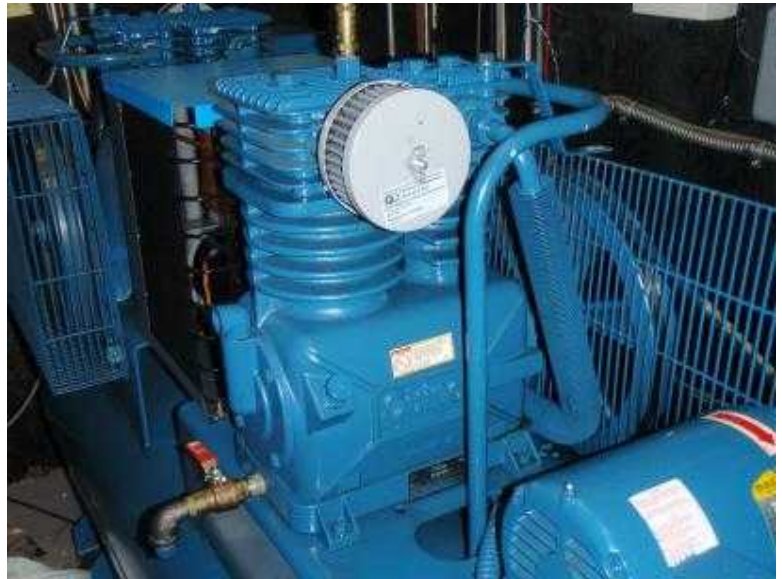
48. 1st through 5th Floor Janitor's Room Floors: Concrete Repair/ replace the oil leak at the bottom of the Quincy compressor in the electrical closet on the third floor.

| 1st through 5th Floor Janitor's Room Floors: Repair/ replace the oil leak at the bottom of the Quincy compressor in the electrical closet on the third floor. | | |
